Providing Steel Lining for blockouts of Irrigation Outlets -

GOVERNMENT OF MAHARASHTRA,

Irrigation Department,

Circular No. MIS 1083/255(2215)-44J(3);

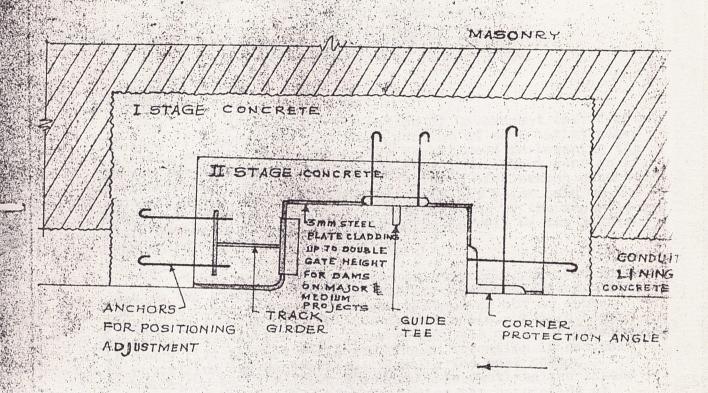
TYPICAL DETAILS OF BLOCKOUT

The block out concrete is generally required to be done in two stages as shown in the accompanying sketch. In the first stage to avoid concrete protruding out of anchor rods, provision of welding pads is desirable. Though both stage concrete is 1: 1/2: 3 or M-200, the quantity involved in every lift is very small and enough attention is not paid to shuttering and concreting. This is the most common drawback for which following special instructions are issued which should be closely observed during the concreting of blockouts for gates and for the blockouts for waterstop of the joints between monoliths of masonry dam.

- ix) Steel plate cladding may be provided to blockouts of outlets upto level at double the gate height to overcome the bulging of concrete, in case of blockouts of gates for major and medium project dams. In additional special case should be taken to ensure smooth finish to blockout concrete as per required dimensions in respect of zones above double gate height level and in respect of blockouts for gates on dams of major, medium and minor projects.
- It is desirable that some temporary cover in form of planks or thin metal sheet is laid over the gate location, after completing the embedments of gates parts up to double gate height to avoid spoiling of gate parts due to droppings from mortar or concrete used for higher level construction. The cover needs to be removed before fillingup of the lake up to outlet/level.
