# Manual for Rehabilitation of Large Dams

Doc. No. CDSO\_MAN\_DS\_02\_v1.0

**January 2018**

**Central Water Commission  
Ministry of Water Resources,  
River Development & Ganga Rejuvenation  
Government of India**

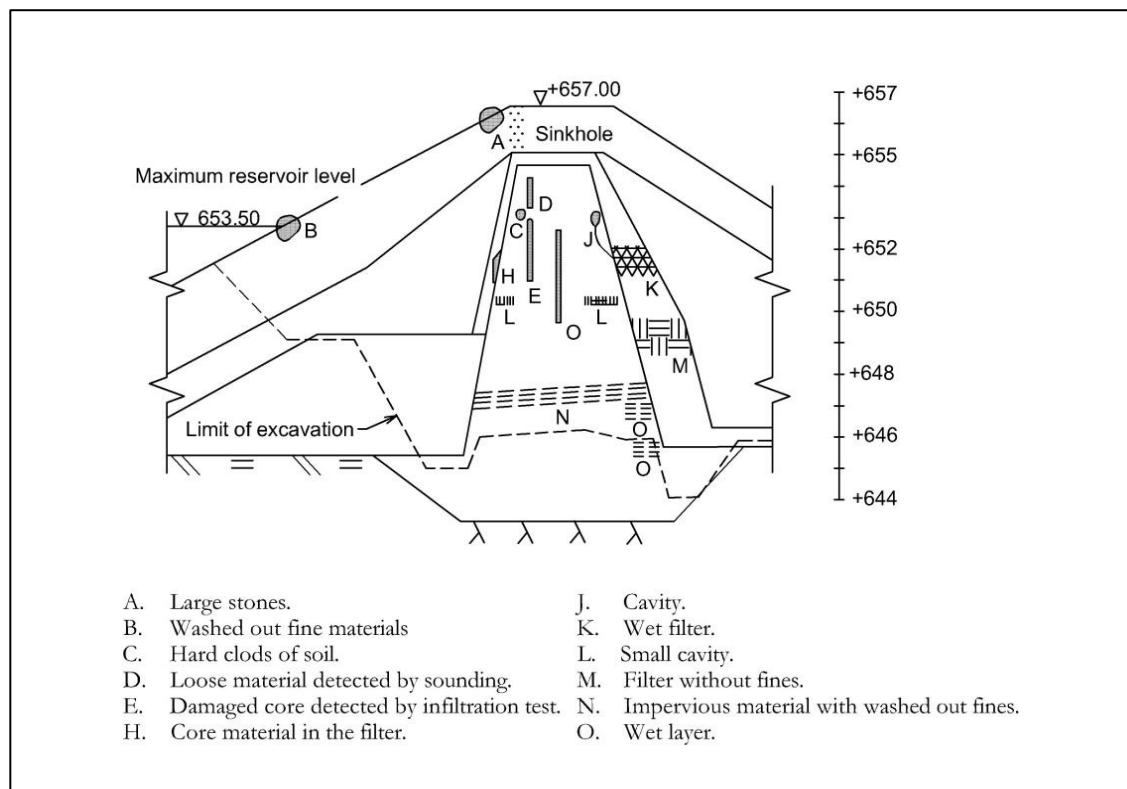
Figure 6-2: Grundsjon Dam, Sweden - Cross section of damaged core

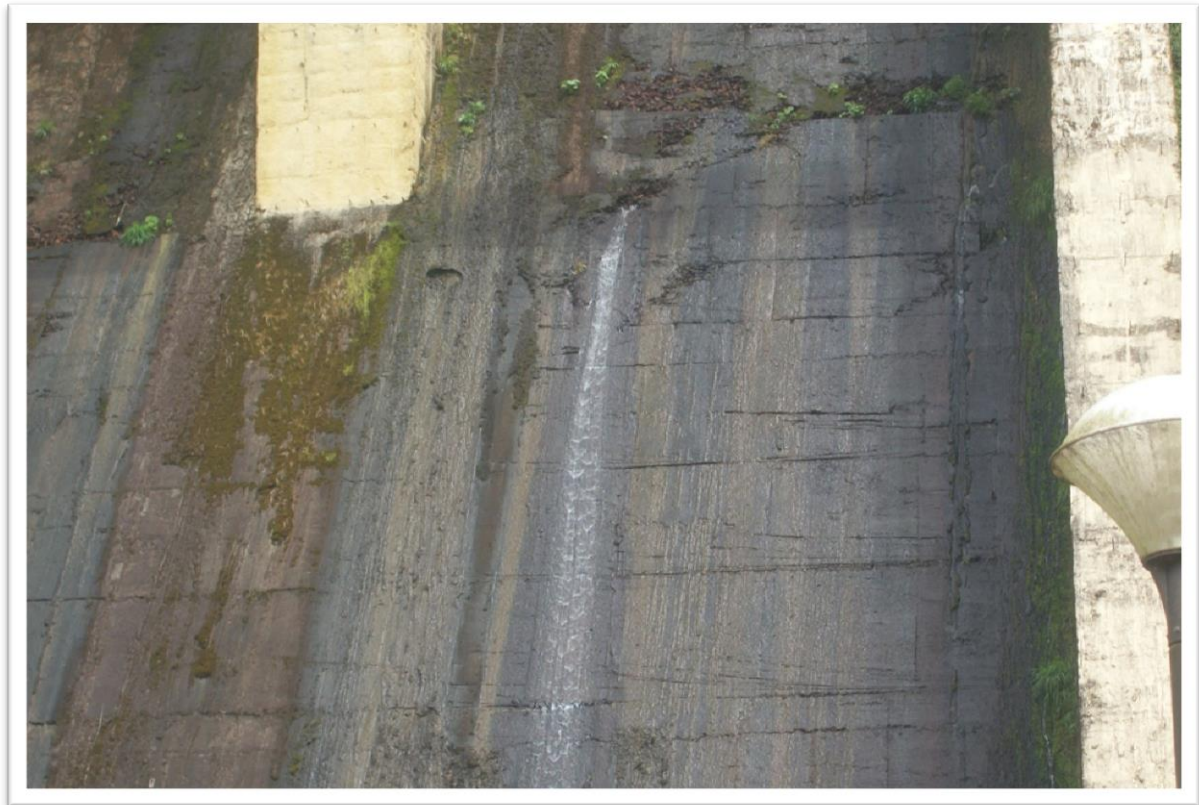
Figure 15 – Photograph showing deteriorated glacial on spillway portion

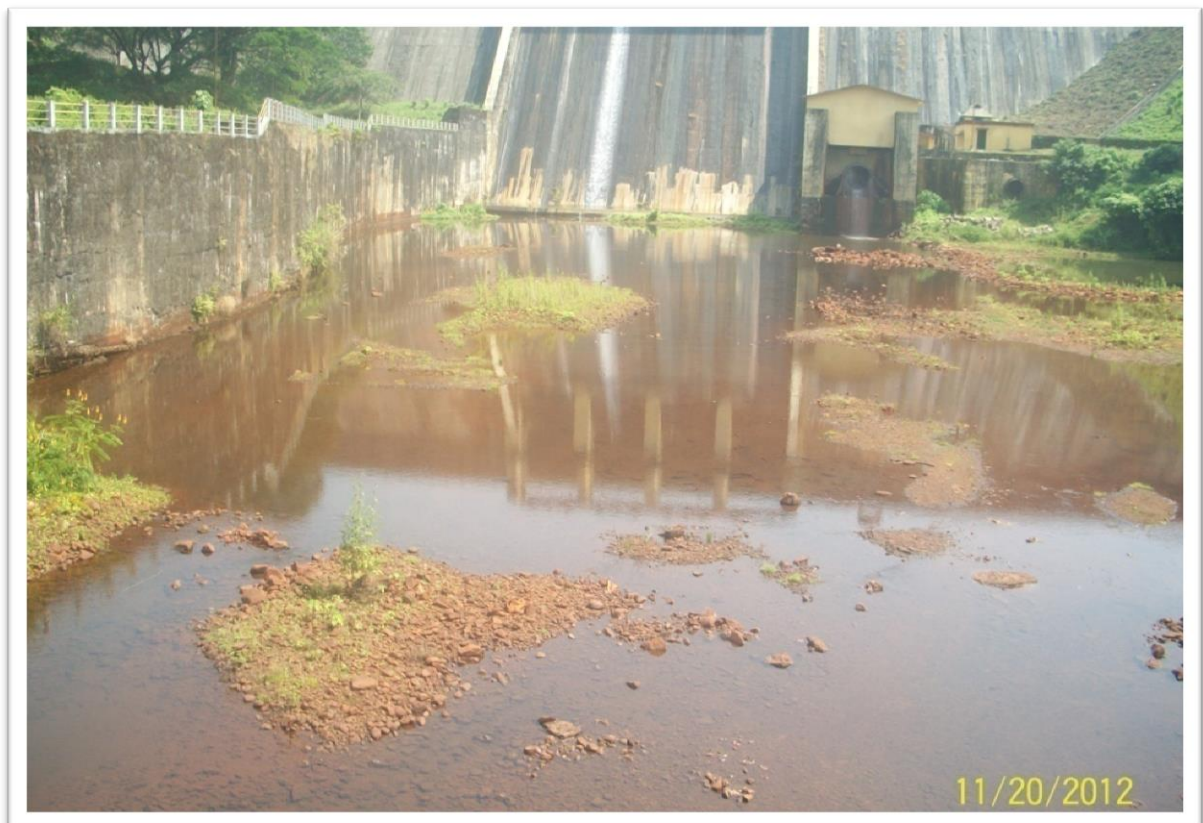
Figure 16 – Photograph showing location of the recommended apron d/s of the bucket

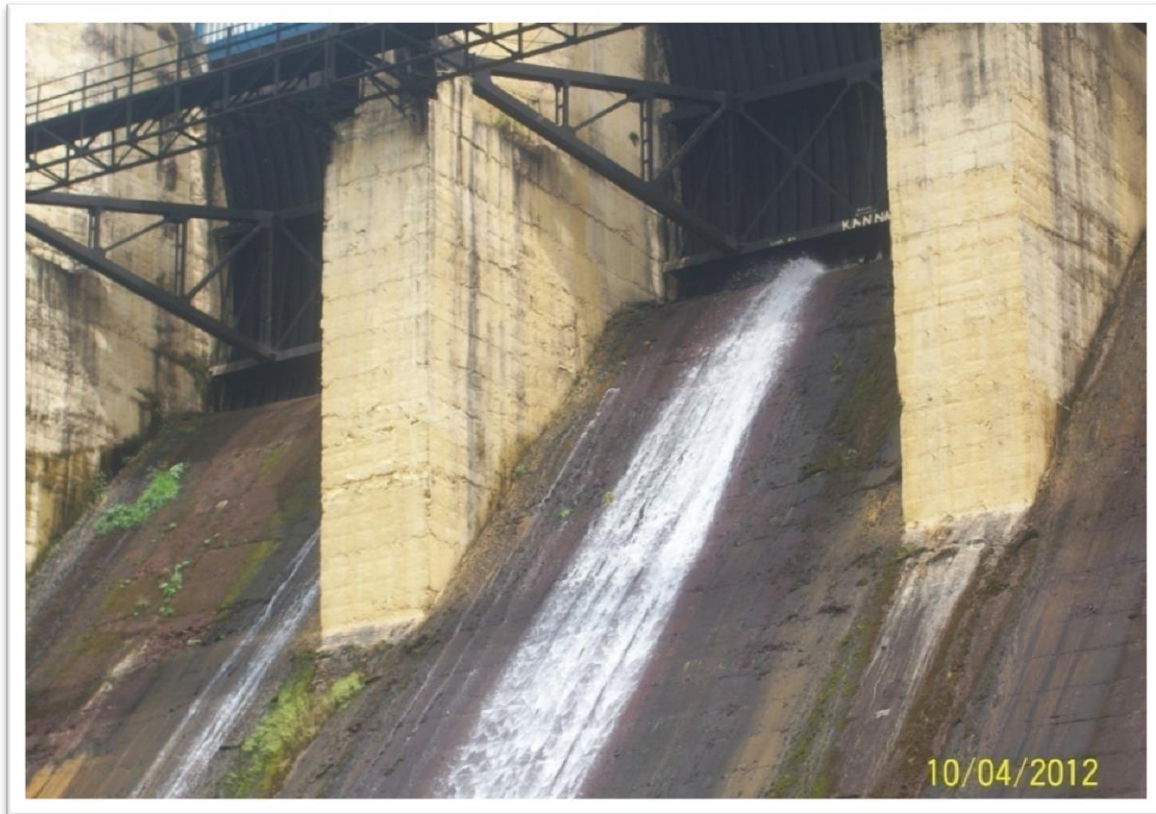
Figure 17 – Photograph showing damaged rubber seal of spillway radial gate

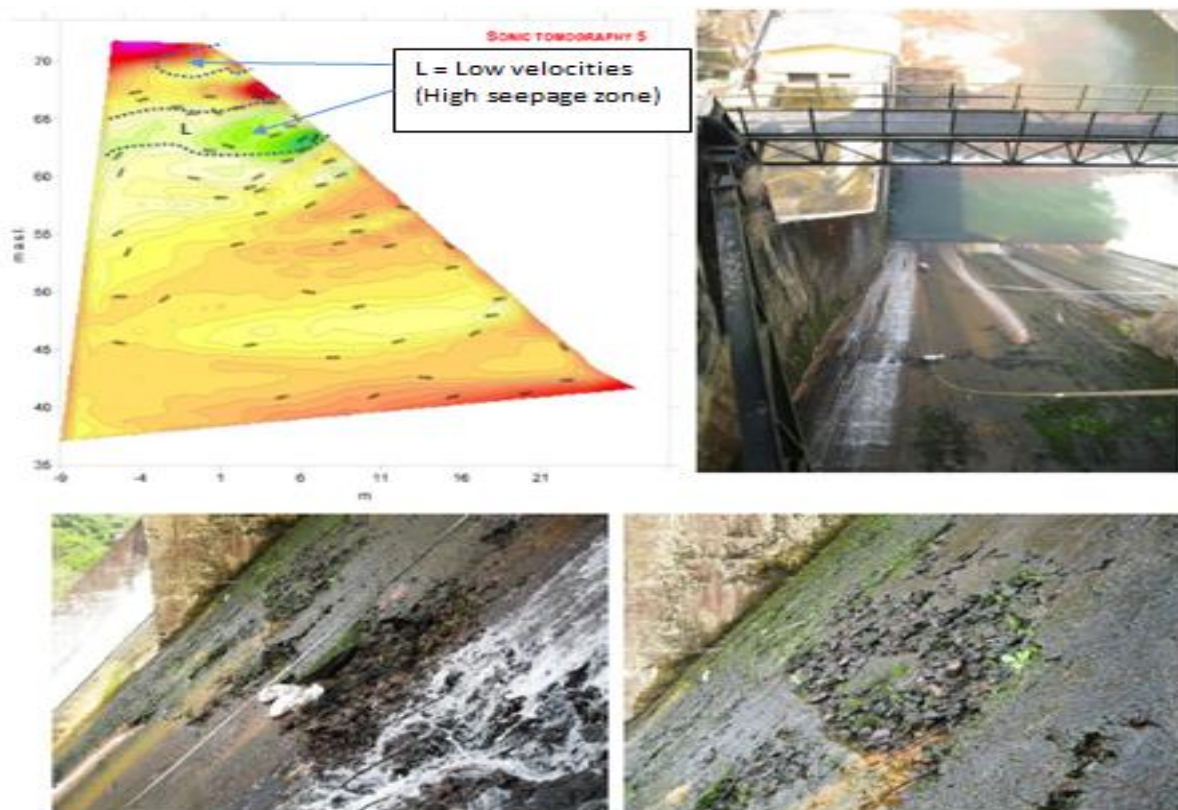
Figure 23 – Sonic tomogram relating to ST-5 and a view of the receiver points on downstream side and some details of damaged areas

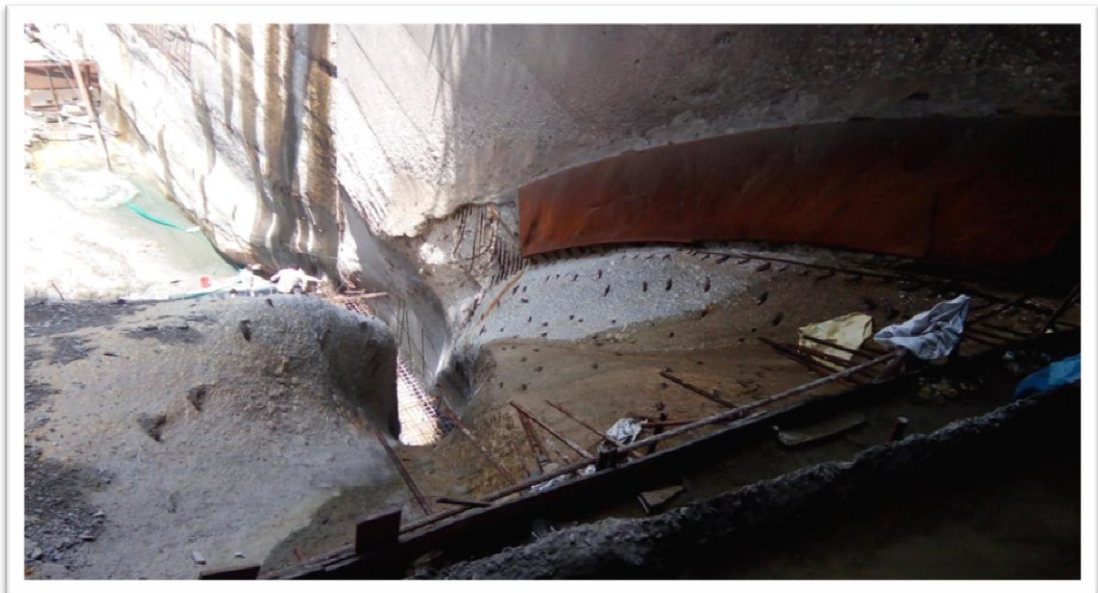
- a) The sill beam of stop log gate and radial gate was washed out in approximately 6.00 m and 8.00 m length (out of a total length of 13 m) respectively. The flange of the remaining sill beams was completely damaged.
- b) As both the sill beams were washed out in some length, therefore a cavity of about 6 - 7 m in length (along with the piers) having a depth up to 2.00 m was created in between the radial gate and stop log gate. The flood also damaged the spillway glacis d/s of radial gate sill beam throughout its length & up to the slotted roller bucket in about 3.00 m width with a varying depth of maximum 13.00 m.

Photograph 1 shows the damages in Spillway bay no-1

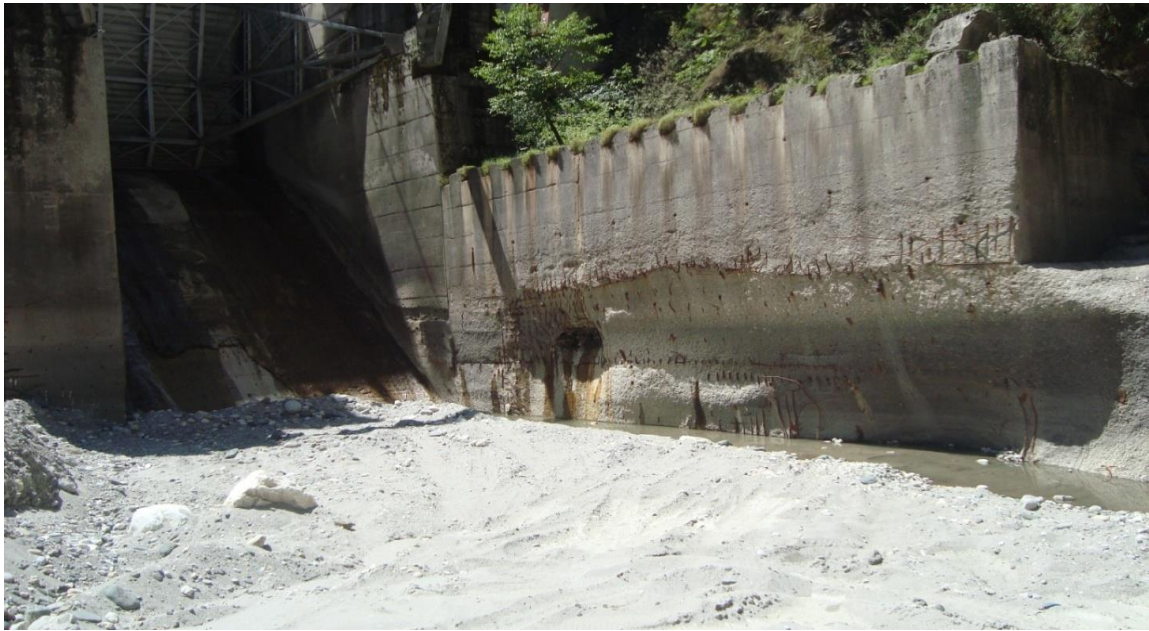
During execution of repair works of spillway bays 1 & 2, the entire slotted type roller bucket and training walls were also examined and it was found that the slots of roller buckets are completely damaged. Both side training wall were also found damaged very badly (Photograph 5). Deep cavities were also found ranging between 1.00 m to 4.00 m in front of all the four bays of roller bucket (Photograph 6).

Photograph 5 (Damaged Training wall)

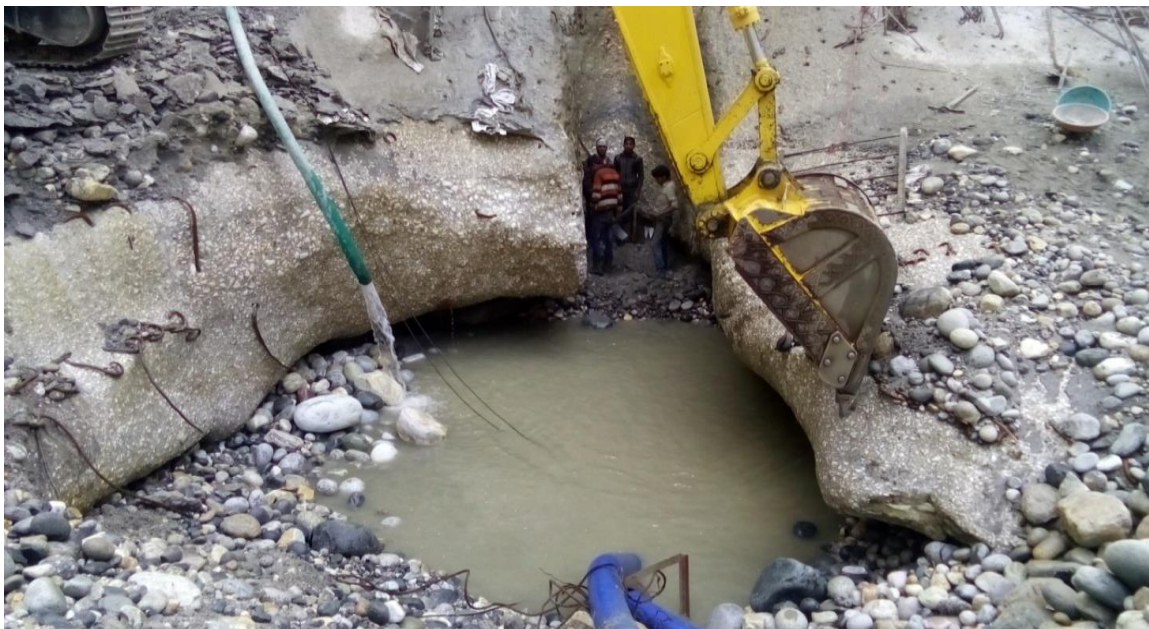
Photograph 6 (Cavity in Slotted Roller Bucket)

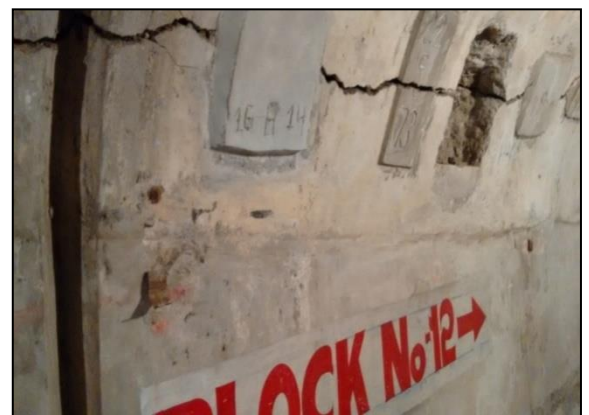
Photograph 4 - Cracks in the Walls of Inspection Gallery

Earlier studies employing numerical modelling (Pant, 1984) had indicated that the surface temperature effects is the major cause of cracking in Konar dam. The studies had ruled out the effect of construction sequence (in the first stage the upstream side of the dam - Stage A was constructed and used for partial storage; the downstream part - Stage B was added later and dam raised to full height (Figure 4)) and the effects of heat of hydration and subsequent cooling on the development of cracks in the dam. In the said study report it was also indicated that “although the present investigation is restricted to a two-dimensional analysis, to interpret the complete behavior of the dam, a three-dimensional analysis is necessary”.

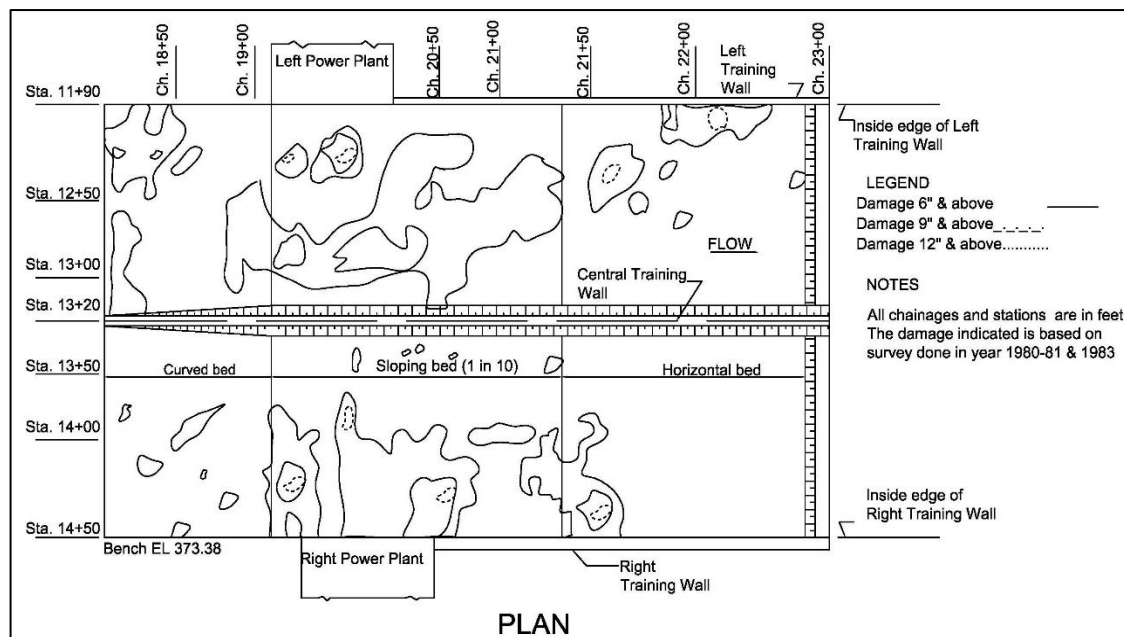
In 1962, the apron floor was cleared of debris/foreign material with the help of divers who reported damage to the floor. A thorough inspection of the bed after clearance of above material revealed general abrasion of the entire floor which varied up to 16 inches. The extent of damage was more pronounced near the side walls as compared to area away from walls. The extent of damage in apron floor is illustrated in Figure 3.

Figure 3 – Damage in Left and Right Spillway

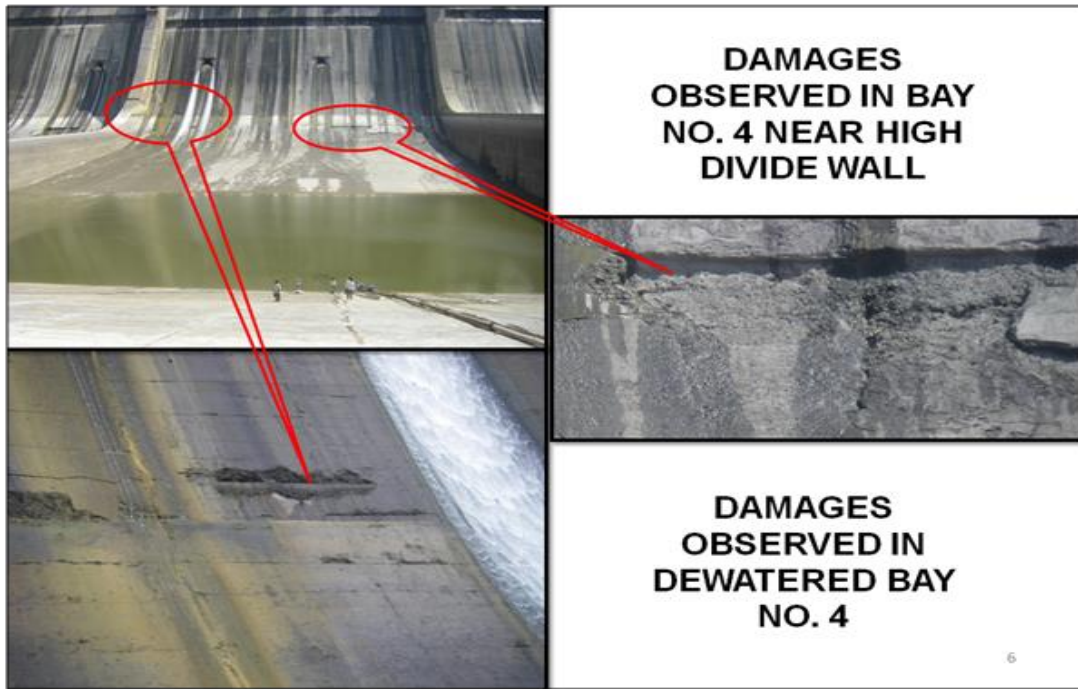
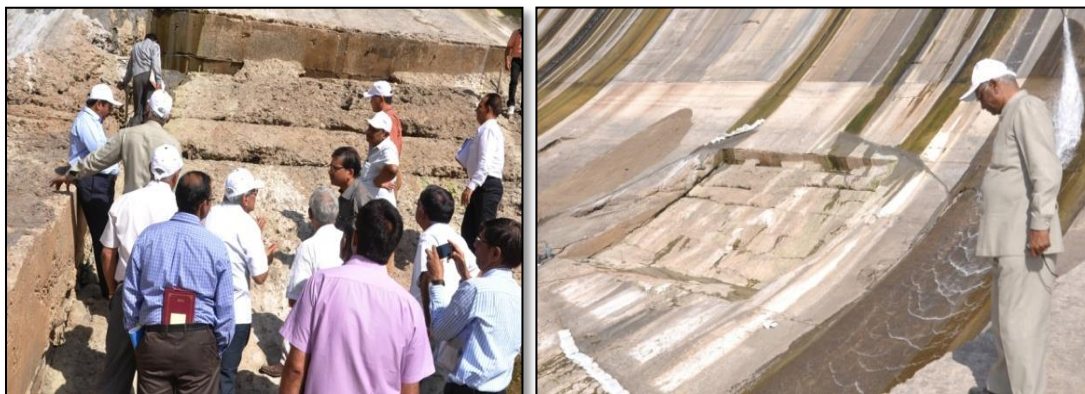
Damages observed in dewatering bay No. 5

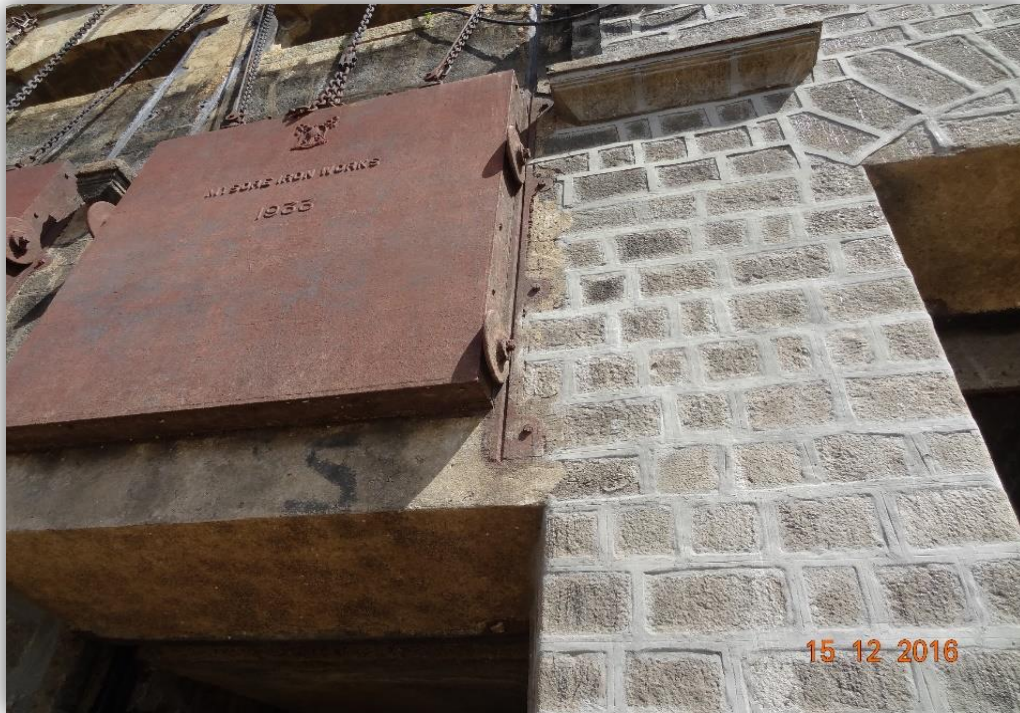
Existing +114' gates presently welded in position. The wheels and the grooved wheel tracks on the right side are visible. Similar track exists on left side also.

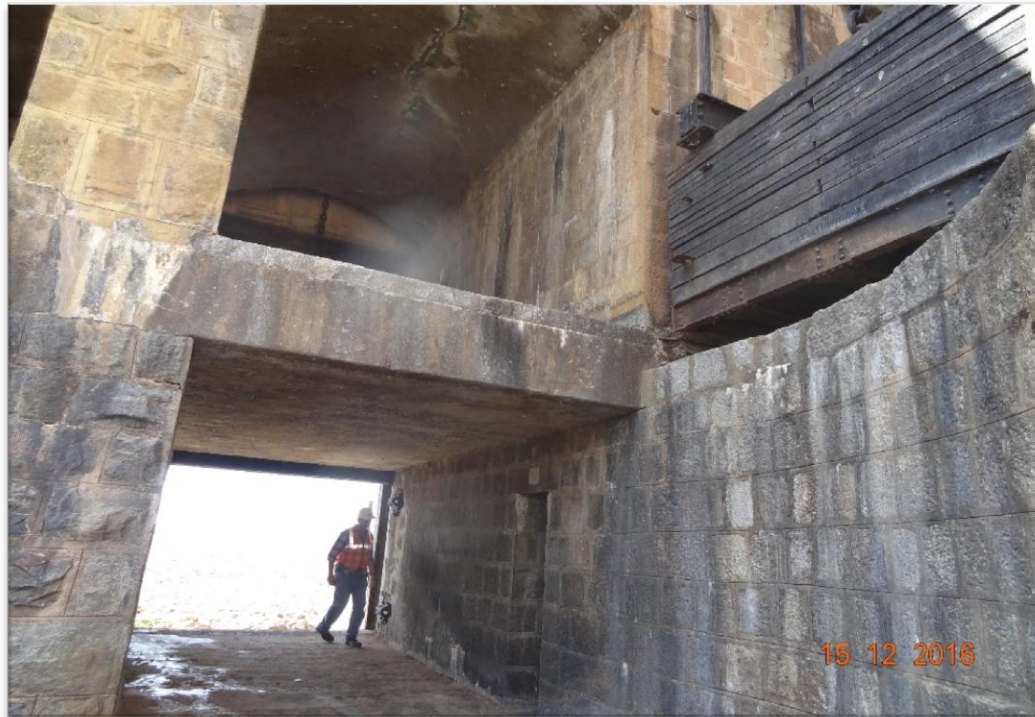
+103' & +114' sluices openings looking from d/s side. The counter weight is visible in suspended condition next to +114' sluice (to be removed, as it may not allow proper aeration of water nappe discharging from +114' gates.)
