**GOVERNMENT OF MAHARASHTRA
WATER RESOURCES DEPARTMENT**

**Annual Consolidated Health Status Report of
Canals and Canal Structures
(2017-18, 2018-19 & 2019-20)
(Based on Test Inspections by DSO, Nashik)**

**Superintending Engineer,
Dam Safety Organisation,
Nashik**

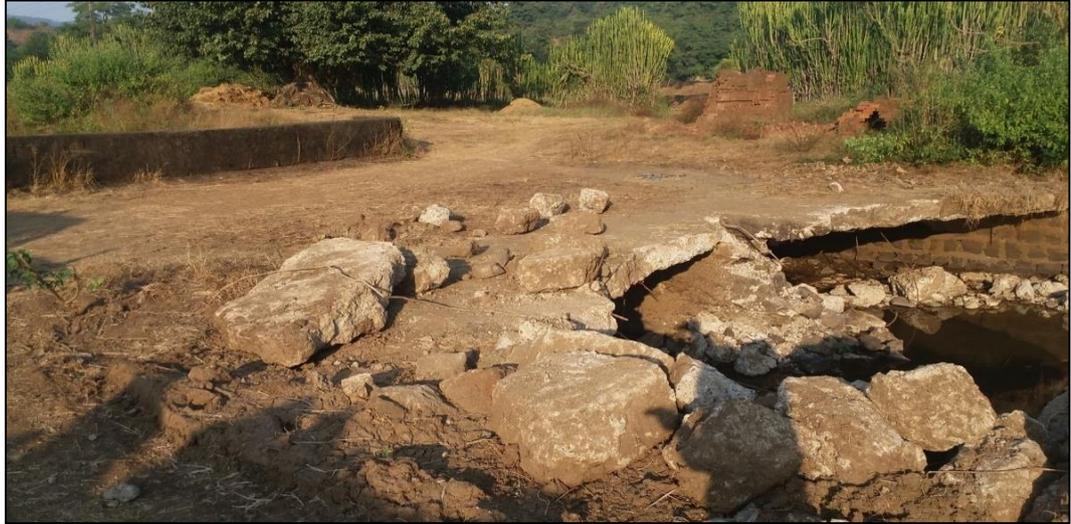
Name of Structure: Super Passage at Ch.9.595 Km.

Deficiency: 1) Railing and Parapet wall damaged.

2) Vent way blocked.

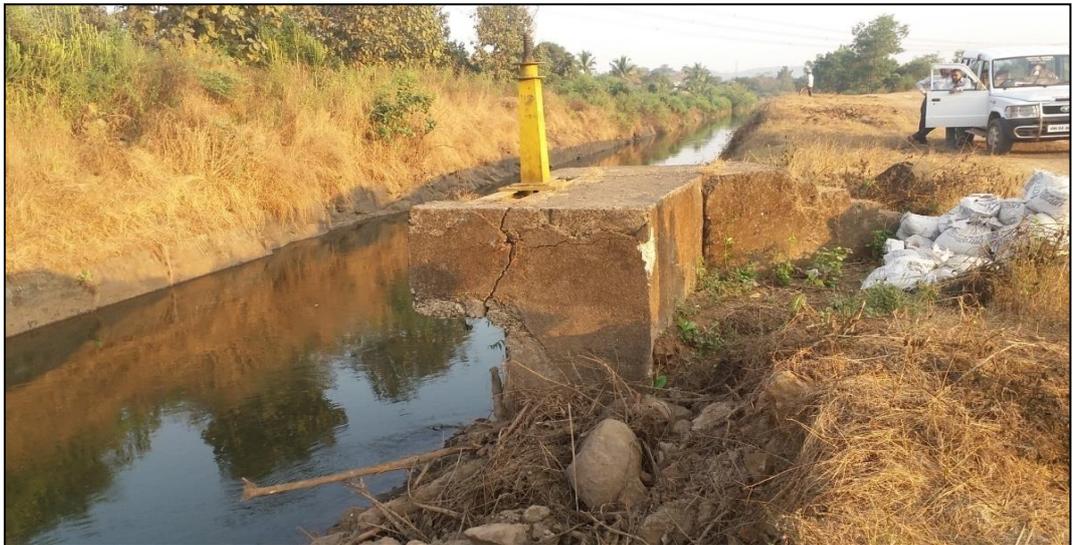
Name of Structure: Head Regulator at Ch. 8.00 km.

Deficiency: 1) Cracked and damaged stone masonry.

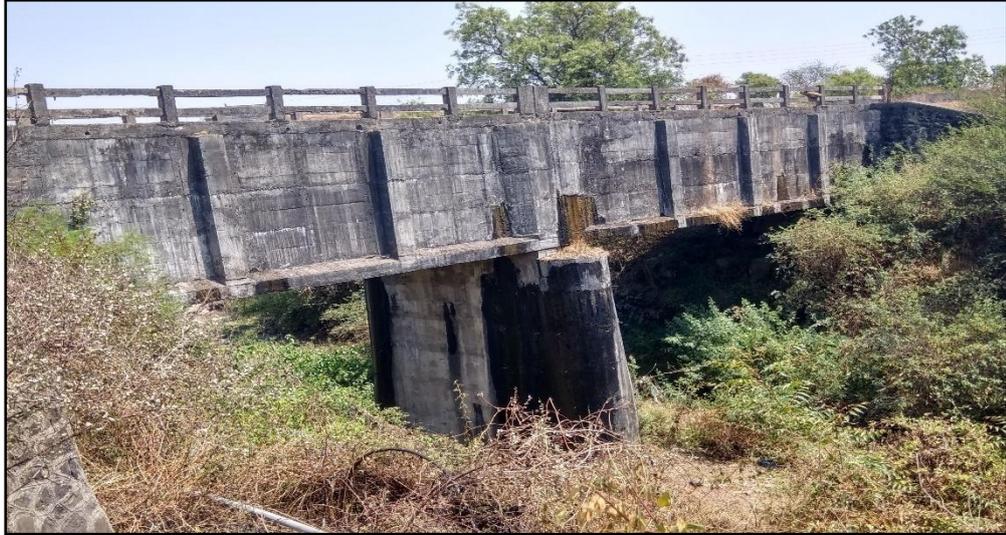
Name of Structure: Aqueduct at Ch. 10.178 km.

Deficiency: 1) Leakage through joint of trough, pier, abutment, wing wall.

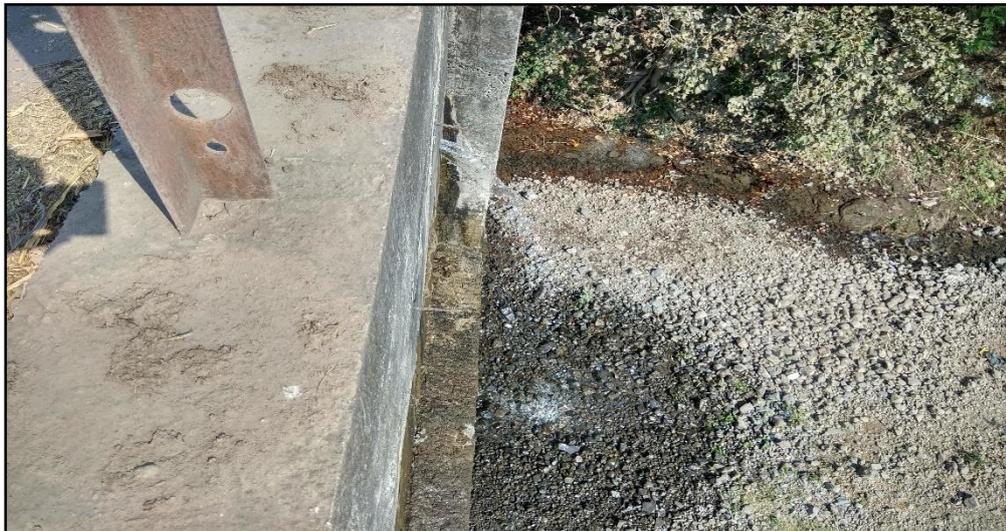
Name of Structure: Aqueduct at Ch. 19.836 km.

Deficiency: 1) Leakage through joint of trough, pier, abutment, wing wall.

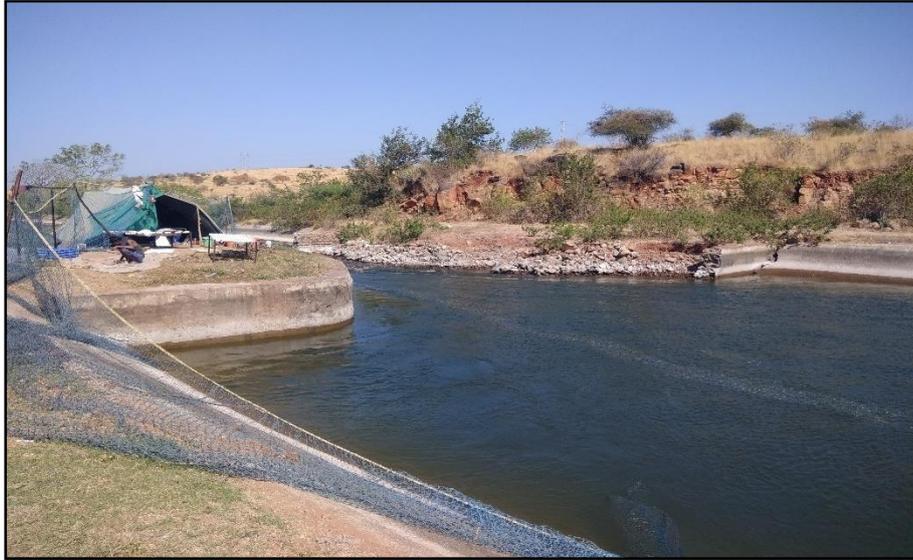
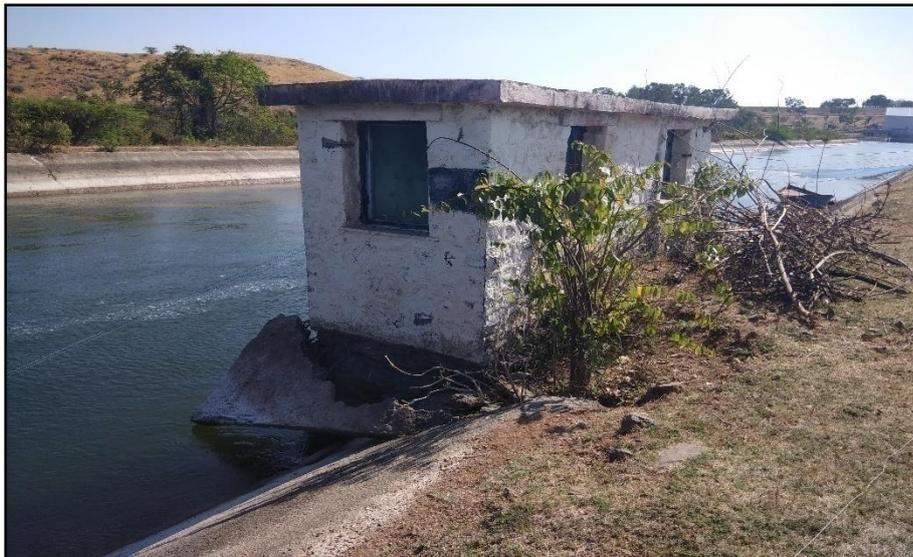
Name of Structure: S.W. F. at Ch. 0.480 km.

- Deficiency:
- 1) Hump portion was completely collapsed. Right side curved guide wall was totally damaged.
 - 2) Gauge chamber was also collapsed. Entrance slab portion of gauge chamber was totally damaged.

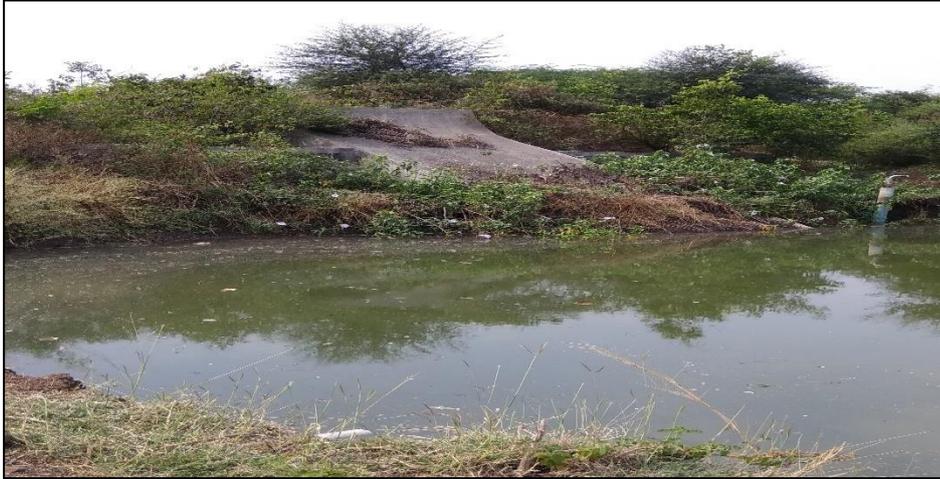
Name of Structure: Syphon at Ch. 15.565 km.

Deficiency: 1) Leakage was found through the RCC barrel in the nalla.

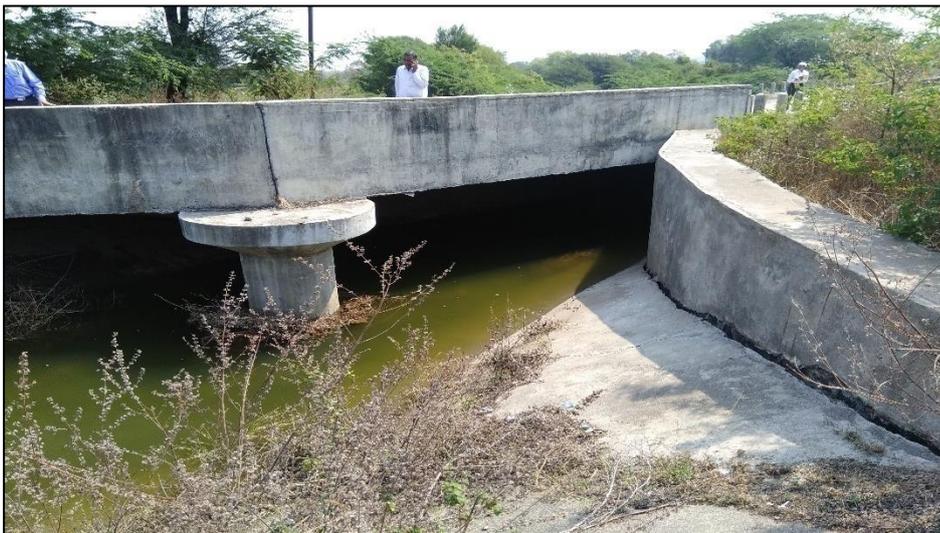
Name of Structure: Aqueduct at Ch. 27.940 km.

Deficiency: 1) The u/s right side guide wall was seen dislocated.

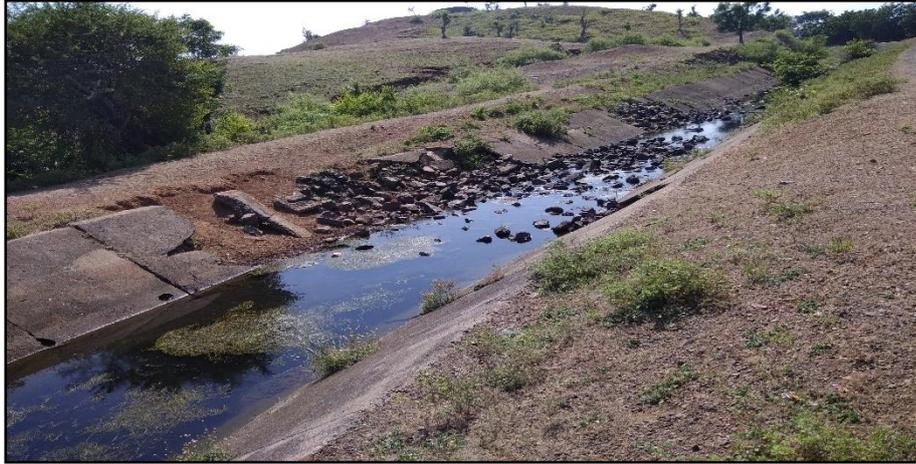
Name of Structure: Canal Section in km. No. 1.

Deficiency: 1) In this section from km 0.910 to 0.960 canal lining was removed.
Stone boulders were fallen in canal section.

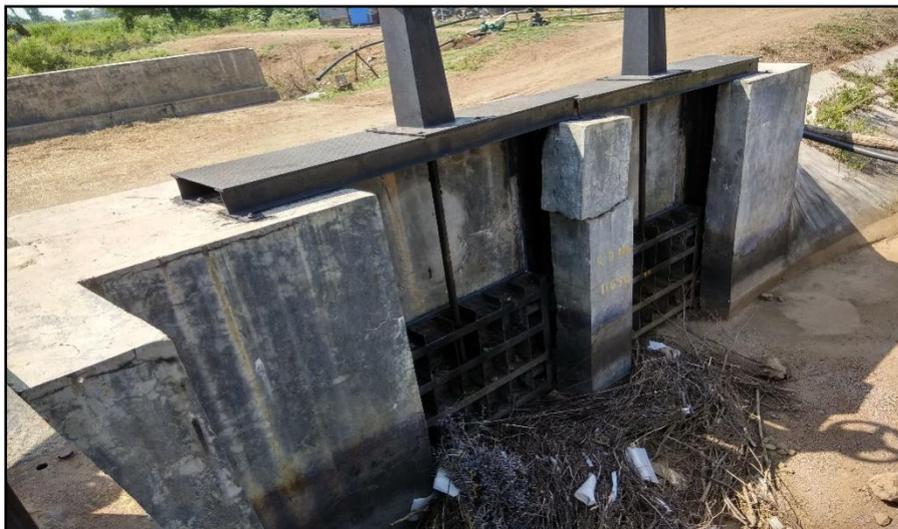
Name of Structure: H.R. cum C.R. at Ch. 11.460 km. (Balkhed Branch)

Deficiency: 1) R.C.C. Center pier of H.R. gate was damaged. Debris was accumulated in front of H.R. gate.

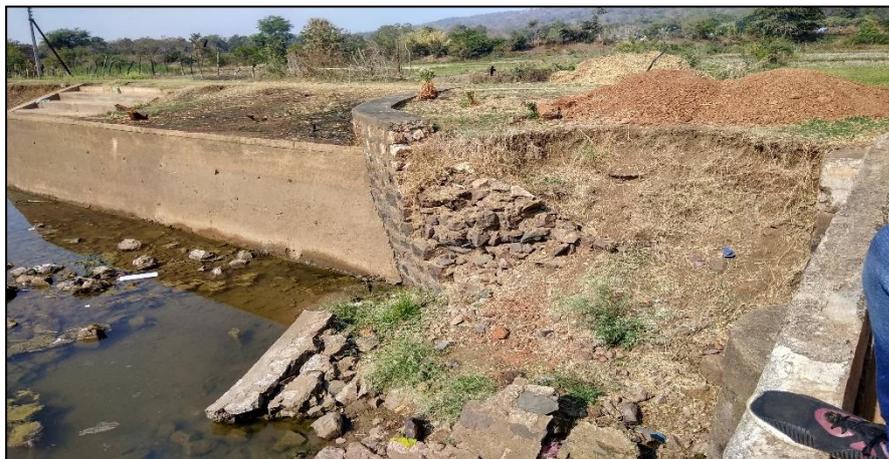
Name of Structure: Cross regulator at Ch. 6.510 km.

Deficiency: 1) The d/s right side curved guide wall has been collapsed.

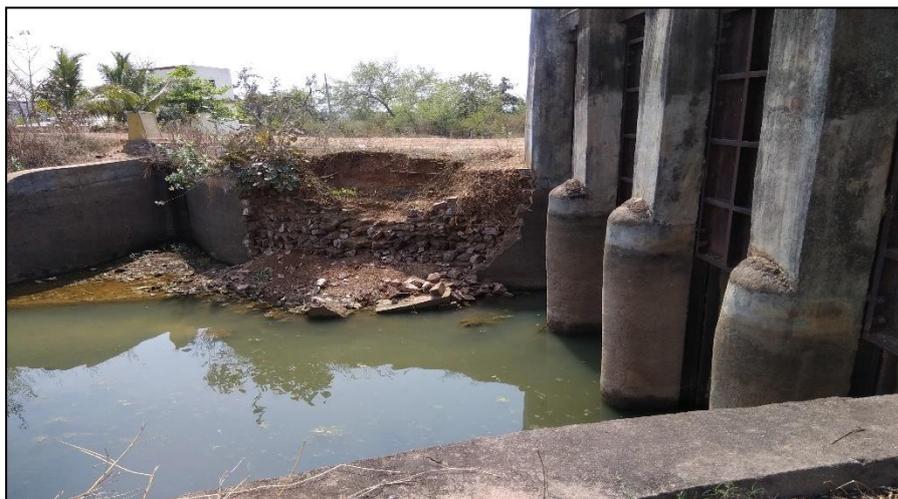
Name of Structure: Cross regulator at Ch. 24.340 km.

Deficiency: 1) The u/s left side curved guide wall was seen completely collapsed.

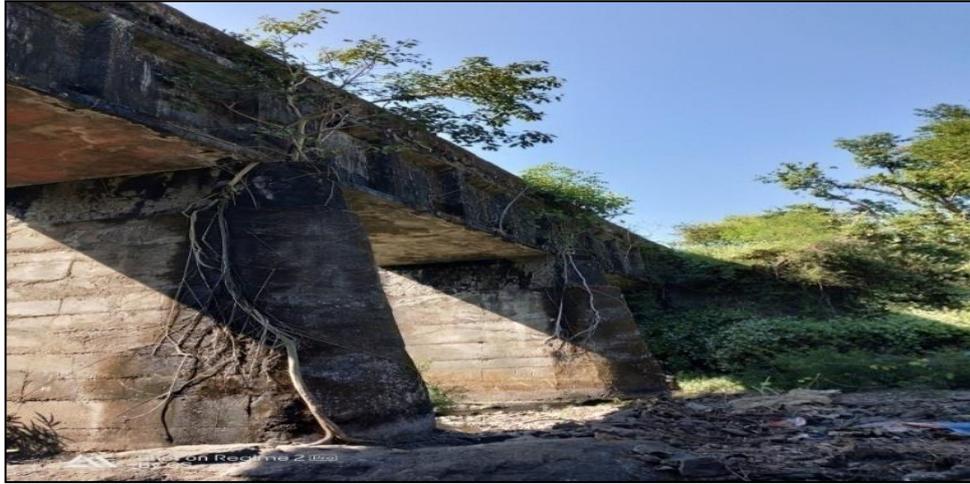
Name of Structure: Aqueduct at Ch. 12.162 Km.

Deficiency: 1) Leakage was observed through bottom of trough.
2) Growth of heavy vegetation was observed on piers, abutment.

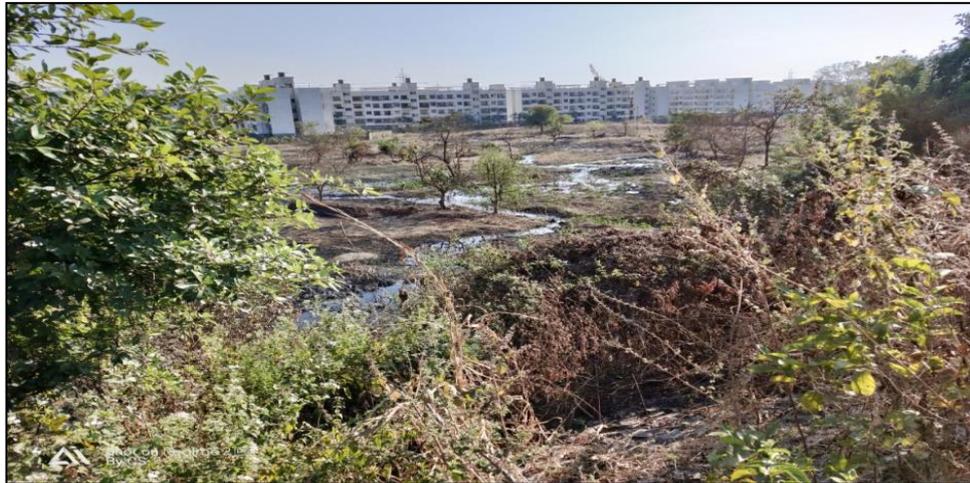
Name of Structure: Canal embankment at Ch. 28.910-29.00 Km.

Deficiency: 1) Heavy leakage was observed through canal embankment.

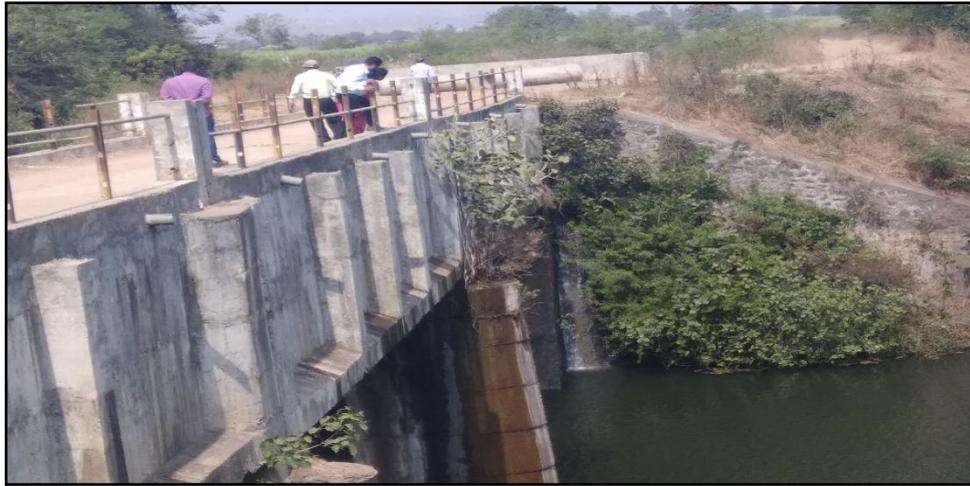
Name of Structure: Aqueduct cum escape at Ch. 7.360 km.

Deficiency: 1) Leakage through joint of trough, pier, abutment, wing wall.
2) Growth of vegetation was observed on wing wall and on top of pier.

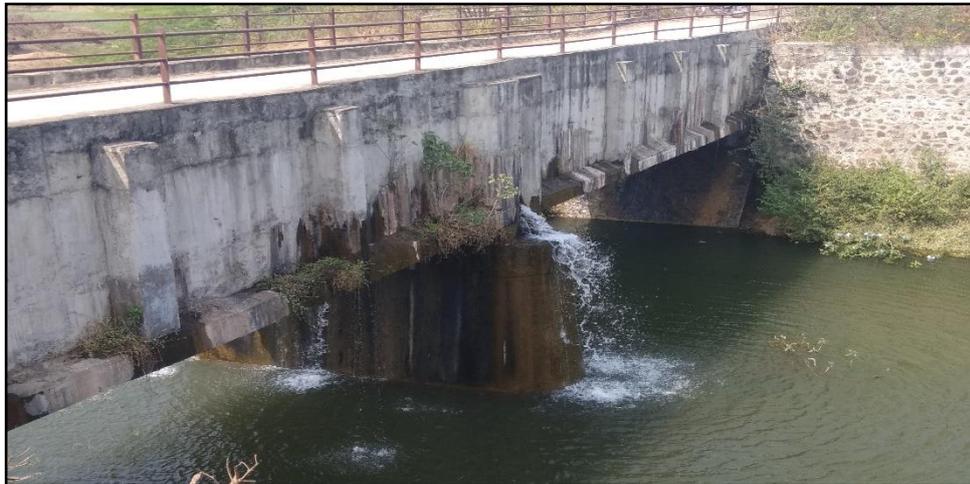
Name of Structure: Aqueduct at Ch. 21.000 km.

Deficiency: 1) Heavy leakage was observed through both left and right side expansion joint of trough near pier and through bottom of trough.

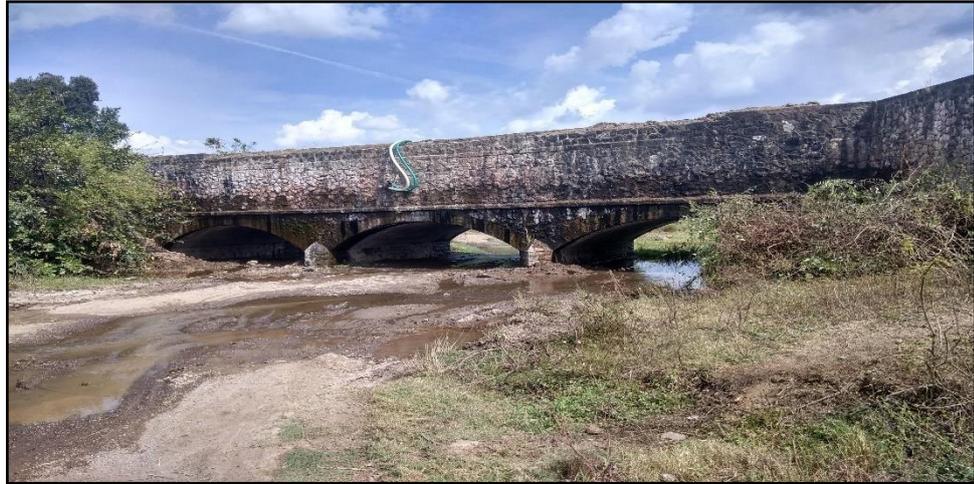
Name of Structure: Aquaduct. at ch. 10.330 km.

Deficiency: 1) Leakage was observed through vertical side of trough and Bottom side of arch.

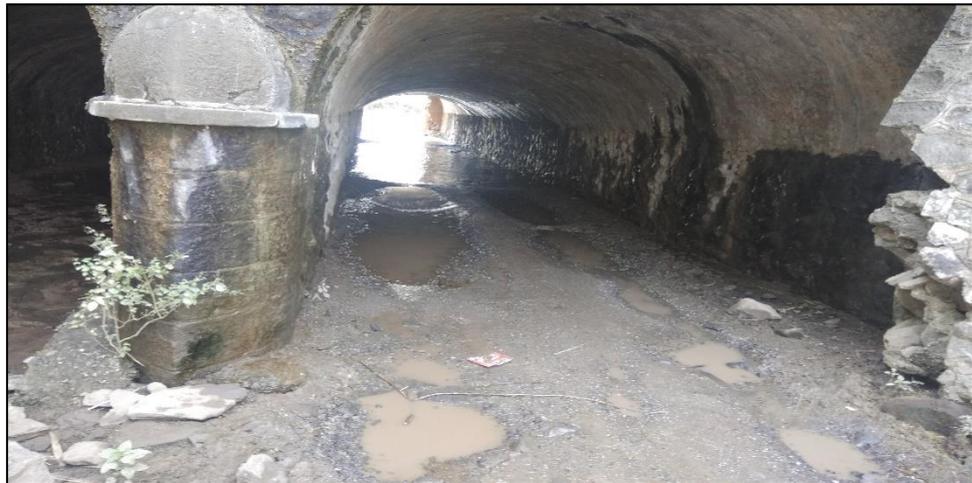
Name of Structure: Aquaduct. at ch. 43.450 km.

Deficiency: 1) Leakage was observed through bottom of arch portion and also through abutment.

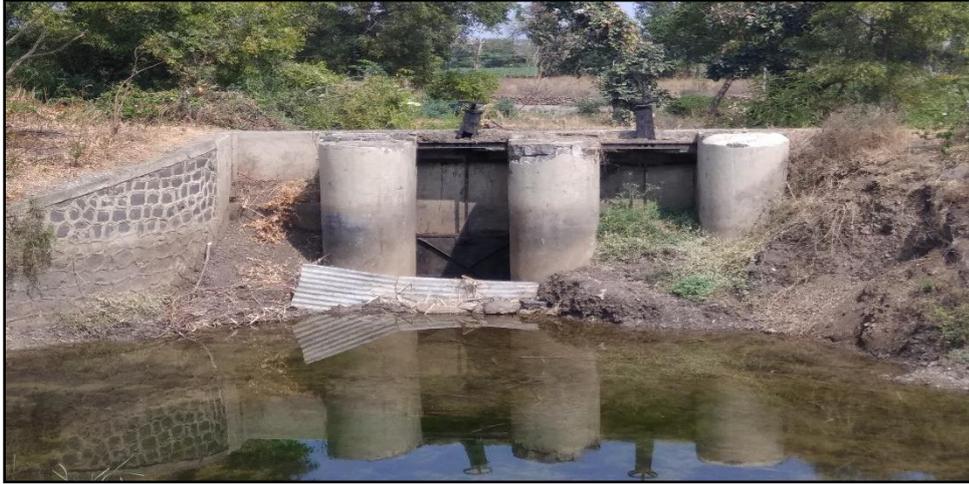
Name of Structure: Escape at Ch.1.380 km.

Deficiency: 1) Escape gate is closed by placing murum in front of gate.

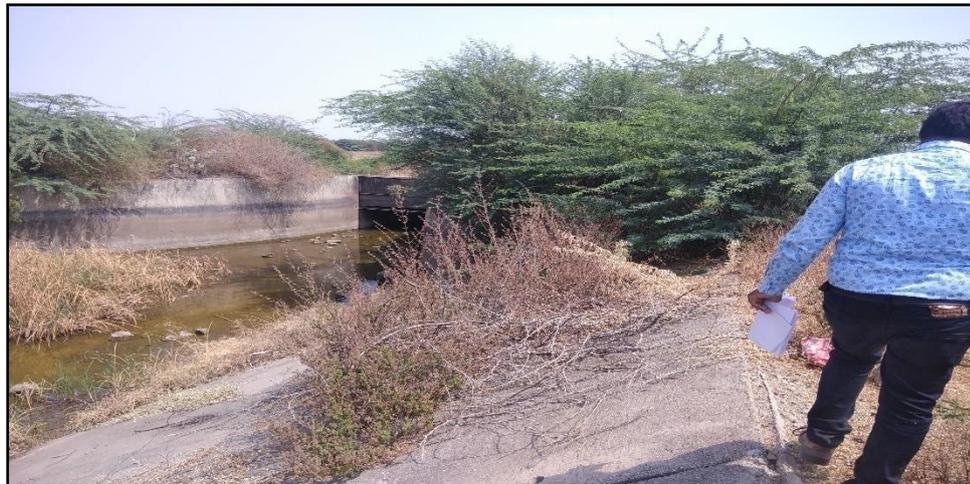
Name of Structure: Syphon at Ch. 3.963 km.

2) Heavy growth of trees was observed at upstream side of the structure.

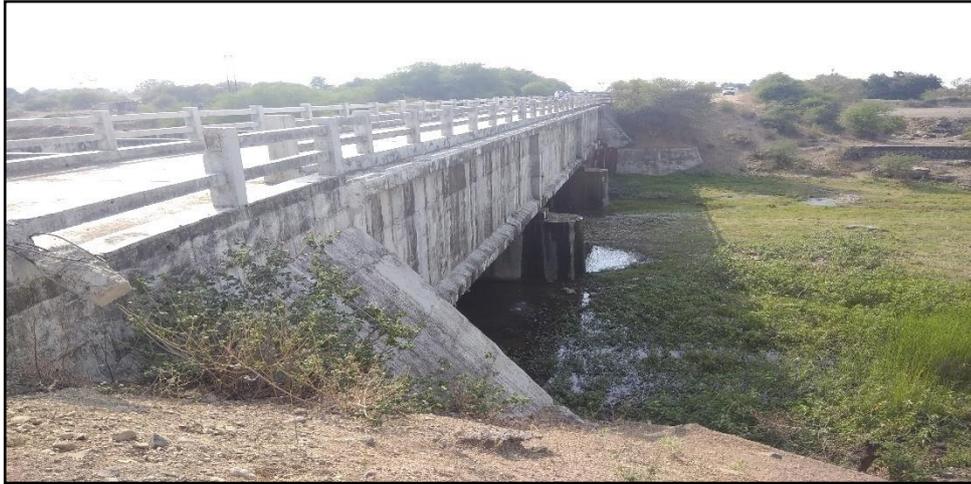
Name of Structure: Aqueduct at Ch. 16.430 km.

Deficiency: 1) Leakage was observed through pier and trough joint.

2) Growth of trees and vegetation was observed near upstream left and downstream right side wing wall.

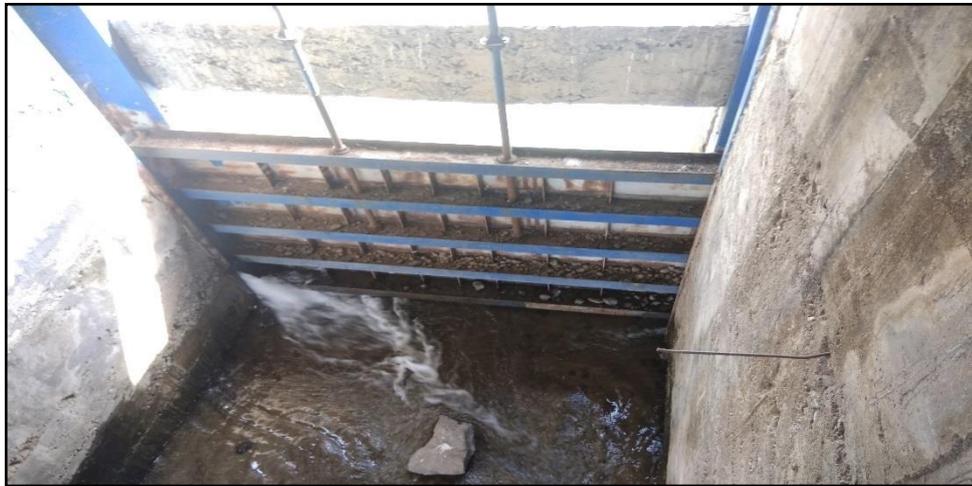
Name of Structure: Cross regulator cum Escape at Ch. 23.565 km.

Deficiency :1) Leakage @ 3 to 4 cusecs through rubber seal of escape gate was observed.

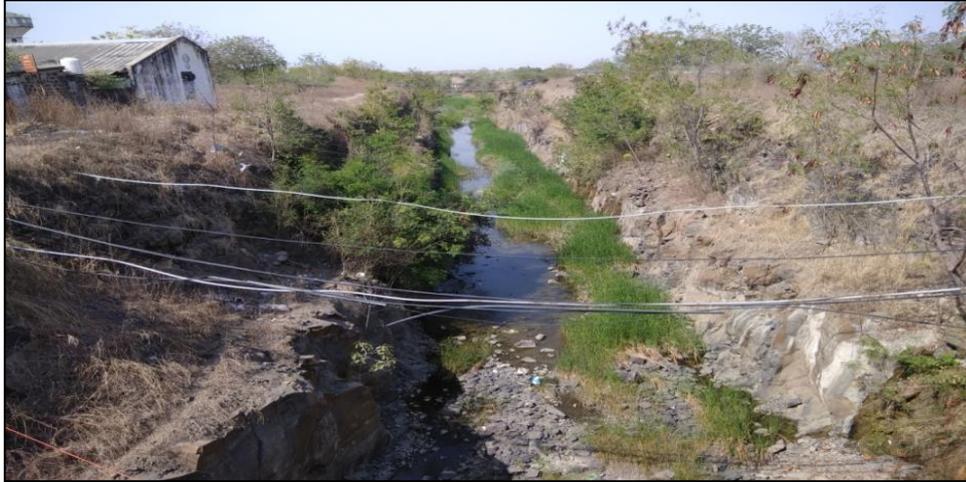
Name of Structure: Deep cut in Km. 28.000.

- Deficiency: 1) Deep cut was full of stagnant water.
2) At some places stone / murum debris was noticed.
3) Vegetation was observed in deep cut.

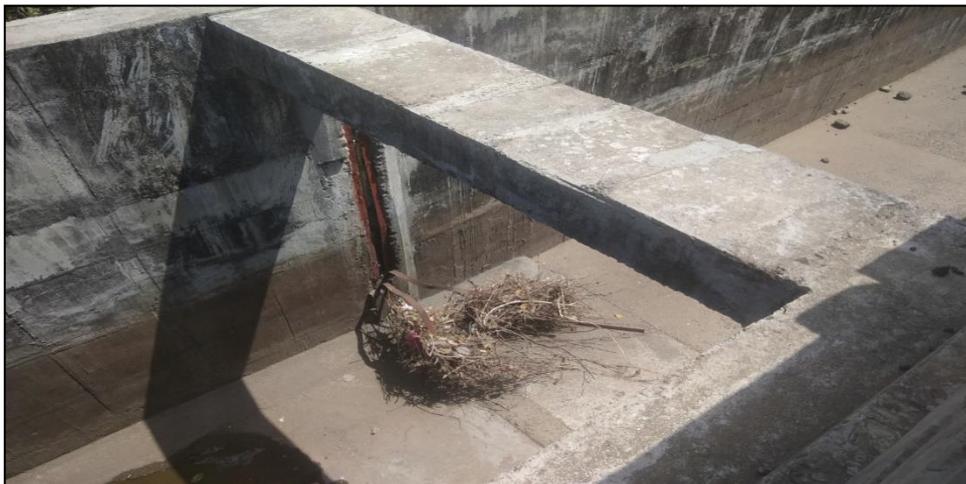
Name of Structure: Aqueduct at Ch. 8.805 Km.

- Deficiency :1) Brass plate provided as expansion joint of the trough is found to be missing at places.

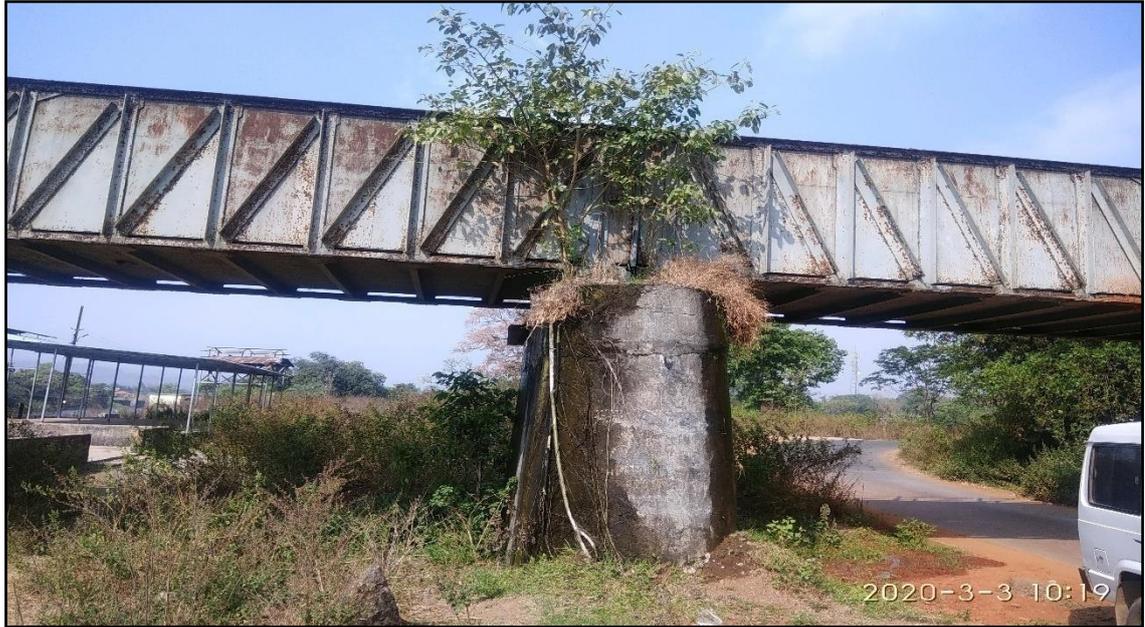
Name of Structure: Aqueduct at Ch. 12.162 Km.

Deficiency :1) Growth of tree was observed on first pier top.

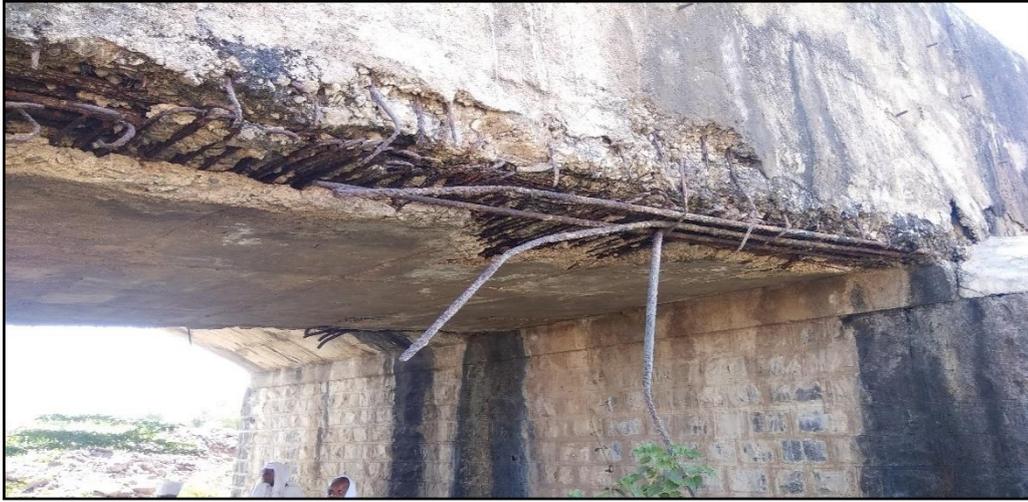
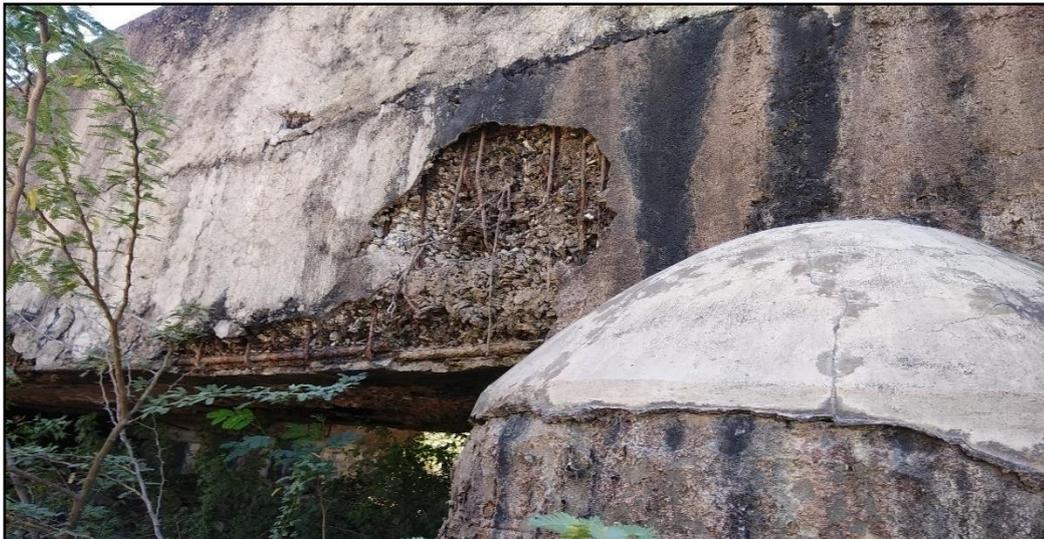
Name of Structure: Aqueduct at Ch 61.900 km.

Deficiency: 1) Reinforcement of bottom and vertical side of trough was exposed and rusted.

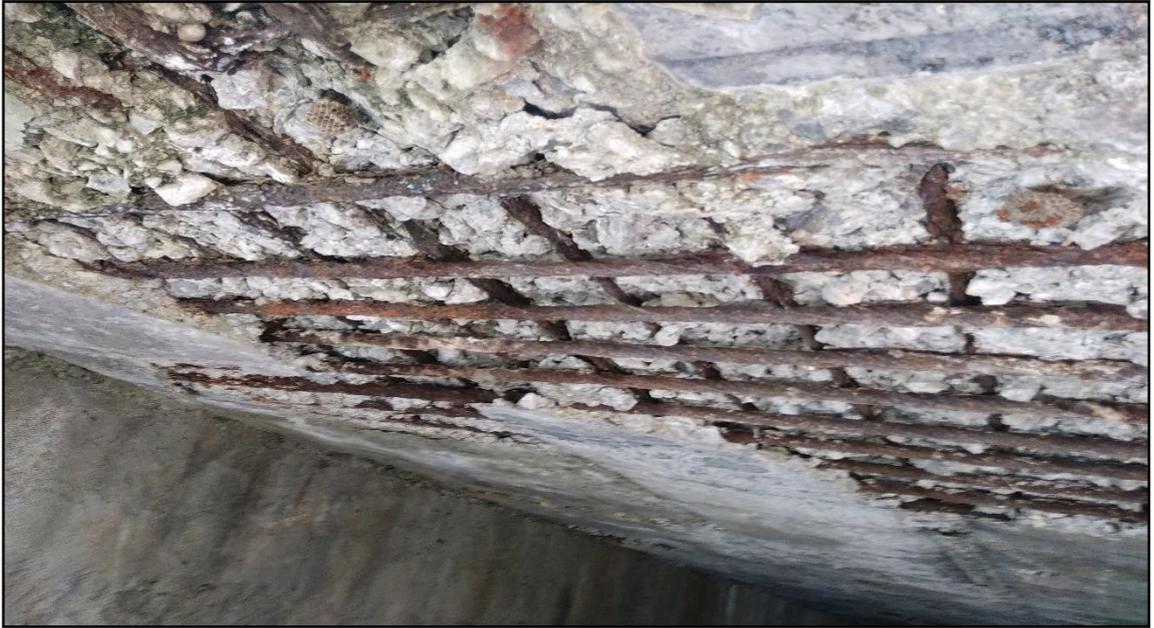
Name of Structure: Aqueduct at Ch. 43.450 km.

Deficiency :1) Reinforcement of bottom and vertical side of trough was exposed and rusted.
