# Manual for Rehabilitation of Large Dams

Doc. No. CDSO\_MAN\_DS\_02\_v1.0

**January 2018**

**Central Water Commission  
Ministry of Water Resources,  
River Development & Ganga Rejuvenation  
Government of India**

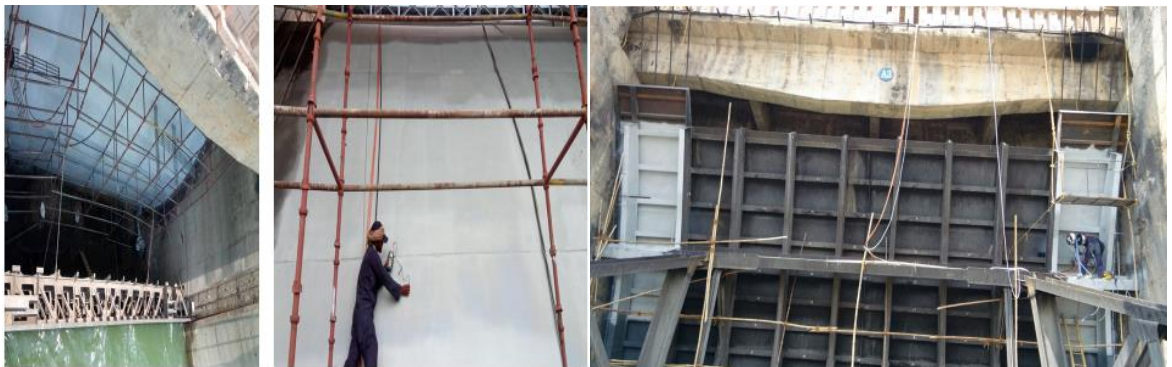
Spillway Gates Zinc Metallizing work at upstream side

Additional Spillway Gates Zinc Metallizing work at downstream side

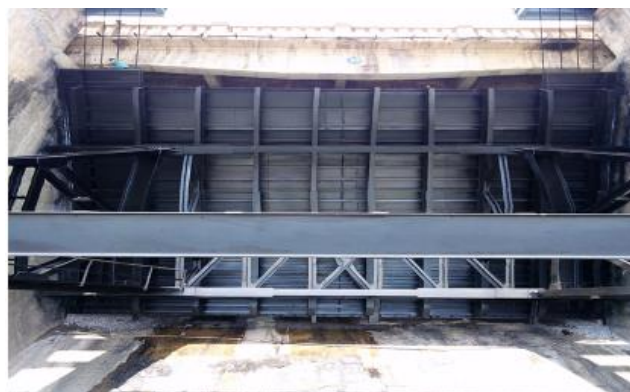
Figure 7-10: Strengthening of Spillway Radial Gates by Zinc Metallizing

Painting to Spillway Gates

- Strengthening of the gate horizontal Girders / vertical stiffeners.
- Sand blasting / Copper slag blasting
- Zinc metallizing (200 micron)
- Application of Zinc Primer (40 Micron)
- Application of Epoxy Coal-tar Paint (2 coats of 100 micron each)

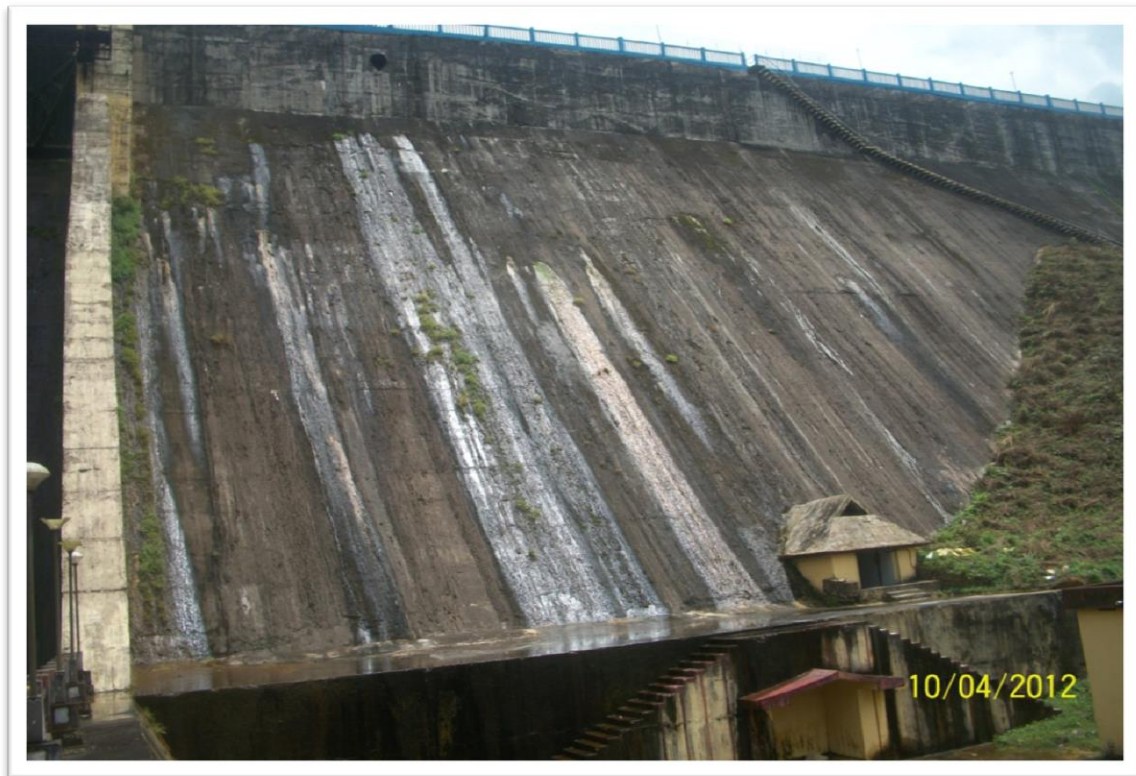
Figure 9 - Photograph showing dam body seepage behind a NOF block

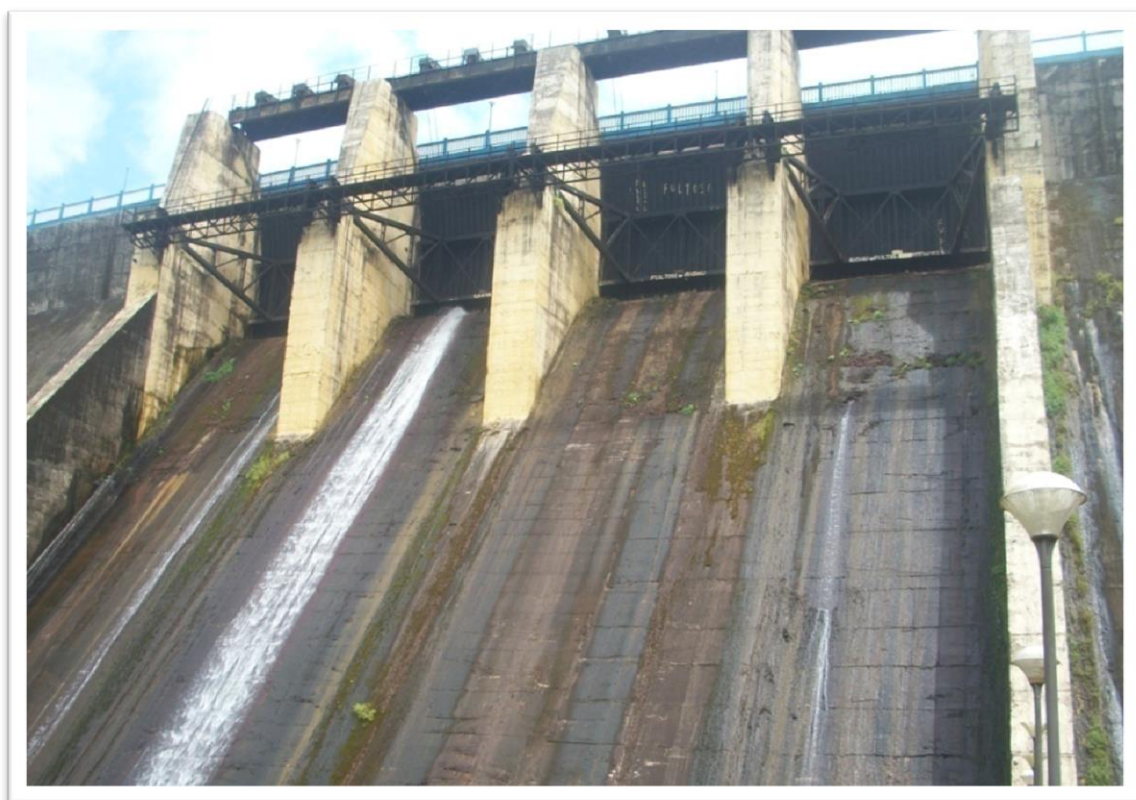
Figure 10 – Photograph showing dam body seepage at spillway portion

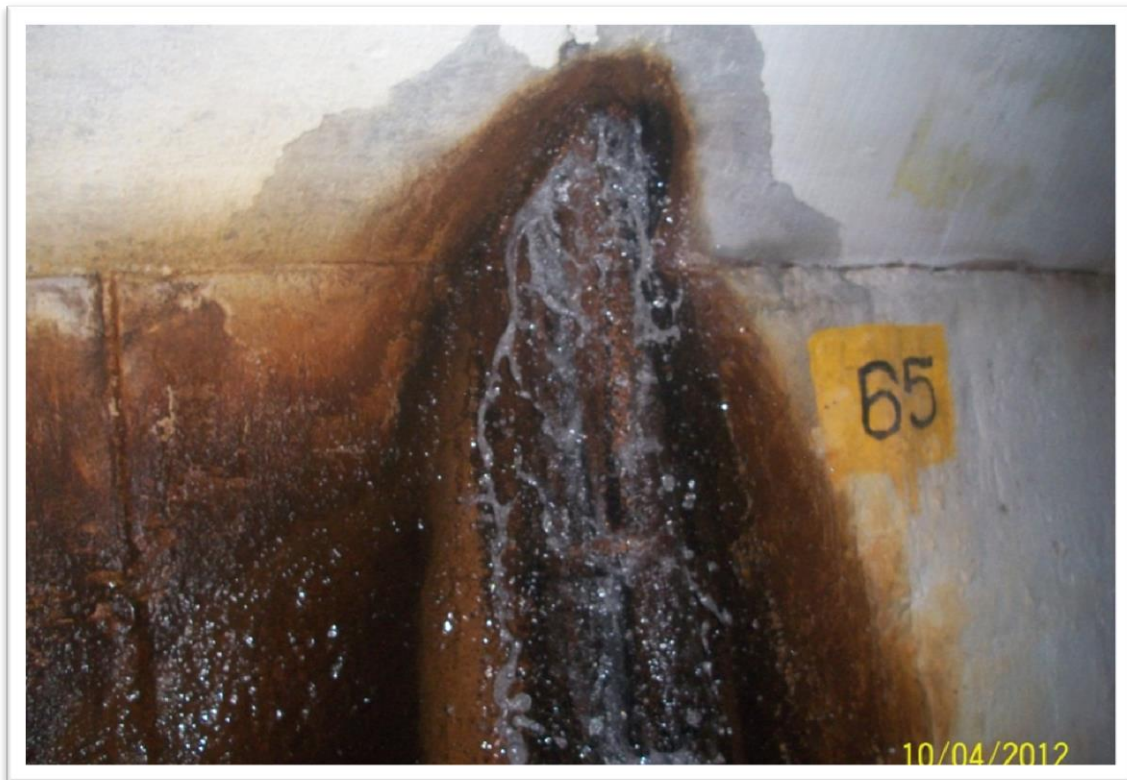
Figures 11 and 12 show excessive seepage from gallery drainage holes. Figures 13 and 14 show choked porous concrete drains.

Figure 11 – Photograph showing excess seepage through the gallery drainage holes

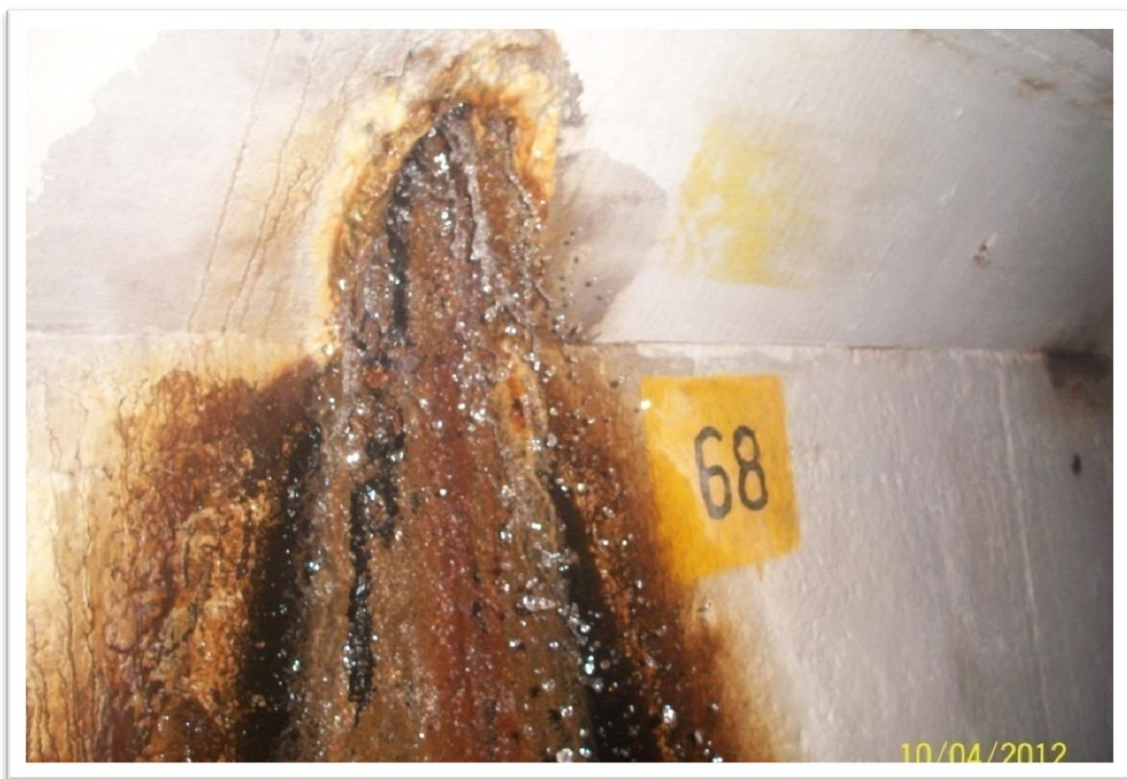
Figure 12 – Photograph showing excess seepage through the gallery drainage holes

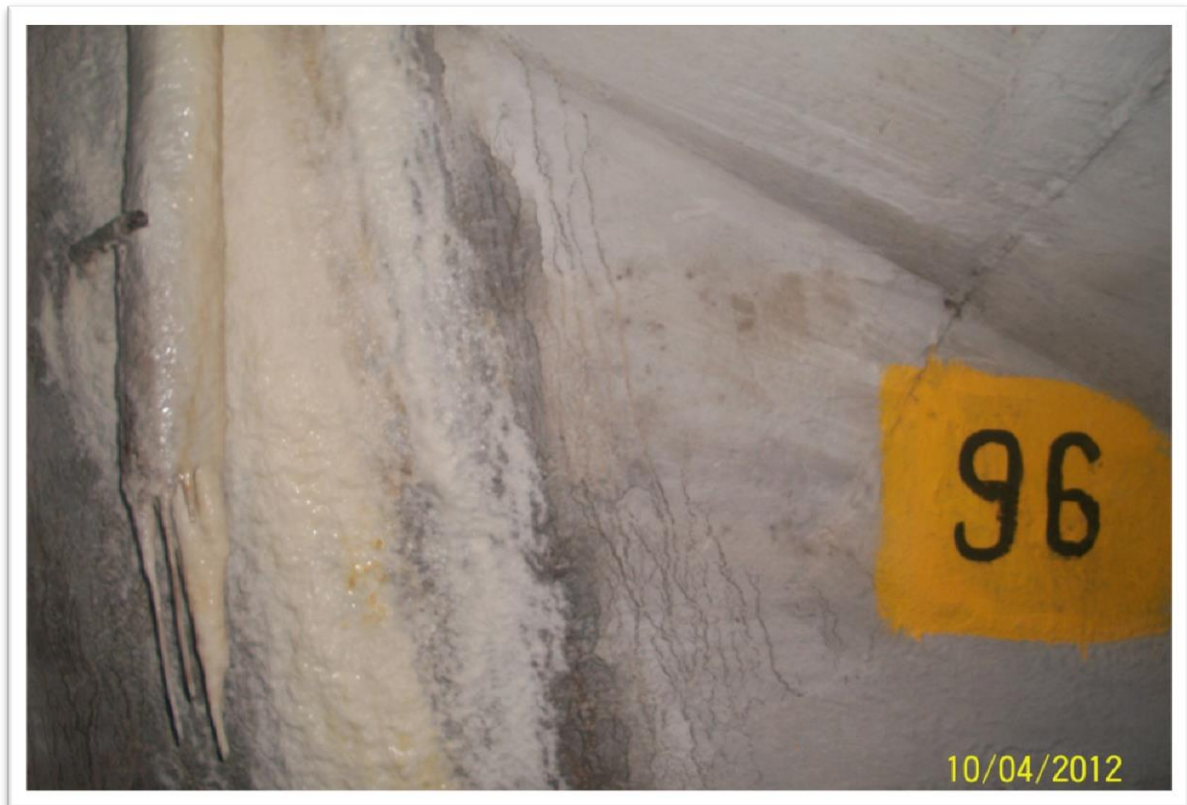
Figure 13 – Photograph showing choked porous holes

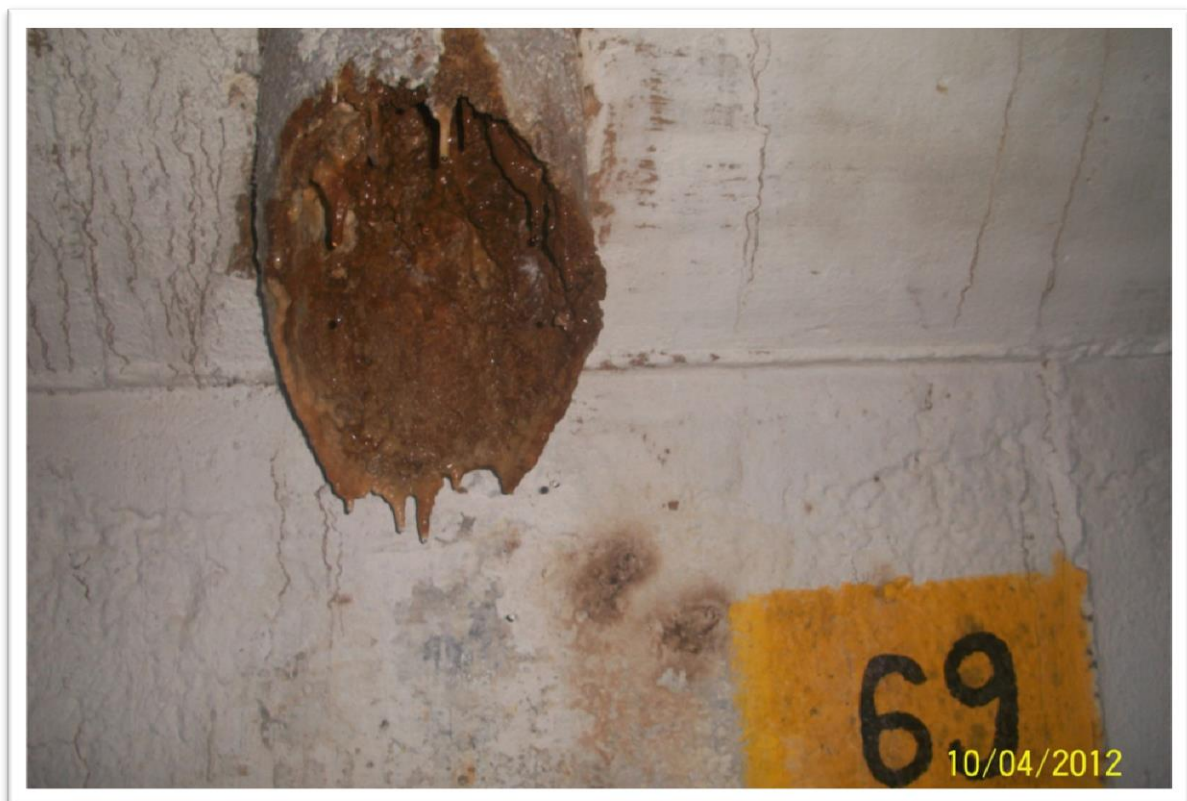
Figure 14 – Photograph showing choked porous holes

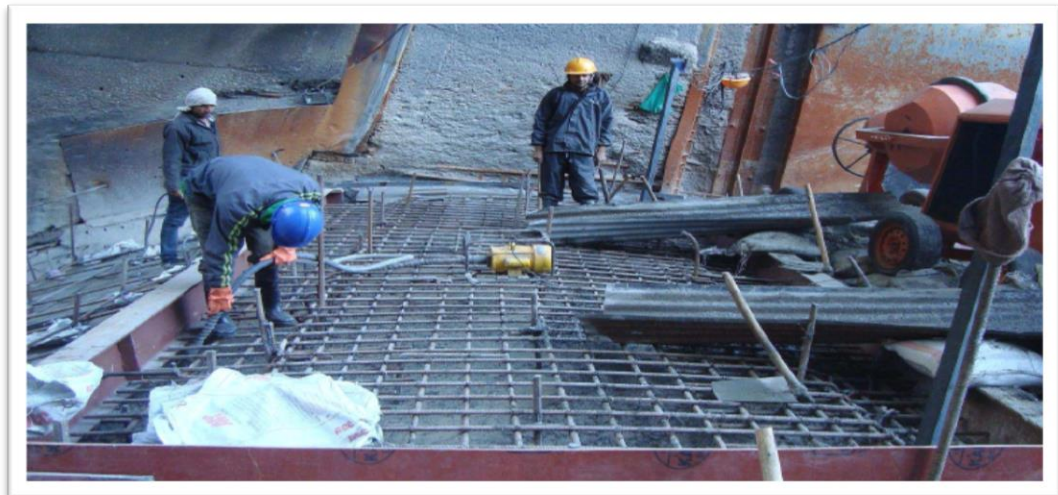
Photograph 3 (Laying concrete in spillway bay no 2)

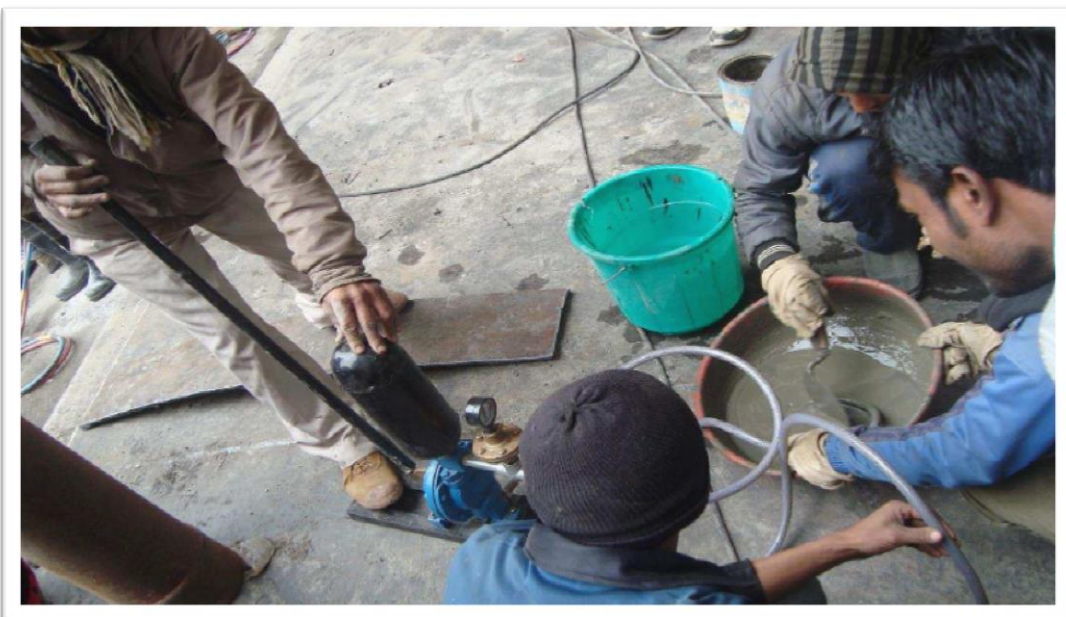
Photograph 4 (Laying and Grouting of MS Plate in Spillway bay no 2)

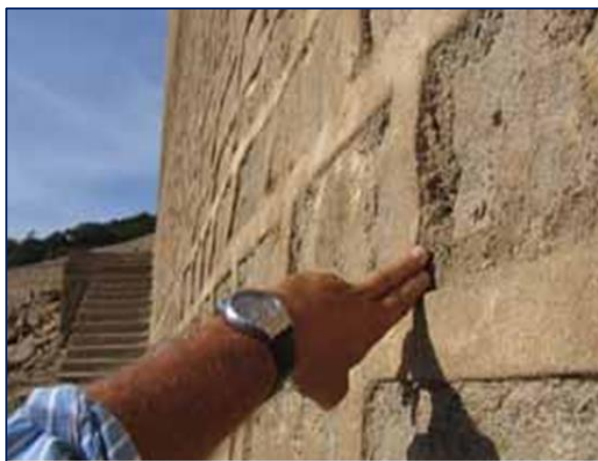
Figure: 1- The stone masonry blocks at the upstream face before being covered by Geo-membrane.

The vertical anchorage lines on the upstream face were planned to be placed at regular 5.7 m intervals and consisted of two components (profiles) designed to provide a tensioning effect on the PVC Geo-composite (see fig. 1, 2, 3). The vertical anchorage system was to be covered by a Carpi patent which incorporates a face drainage system to monitor the efficiency of the liner.

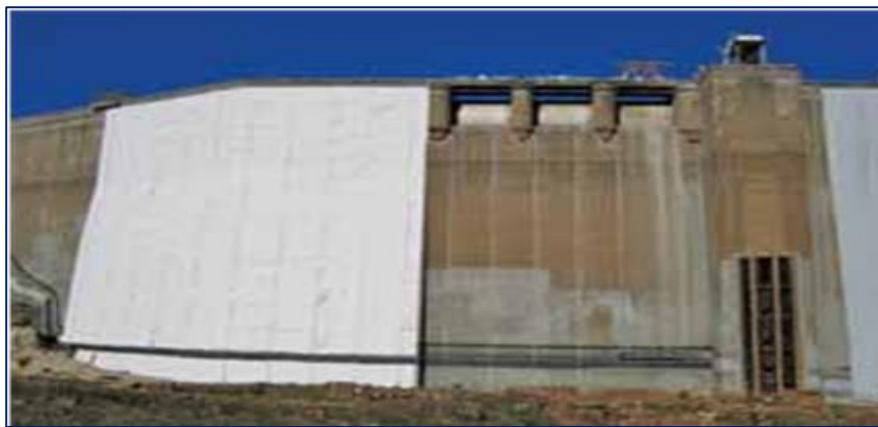
Figure: 2- The vertical anchorage profiles are installed on the u/s masonry dam face of Kadamparai dam at 5.7 m c/c. The anti-puncture geotextile is placed on the dam face between the profiles.

The first components (inner profiles) of the vertical anchorage system were installed directly over the masonry. To protect the Geo-composite against puncturing by the sharp masonry stones, a 2000 g/m<sup>2</sup> geotextile was installed on the masonry surface between the profiles.

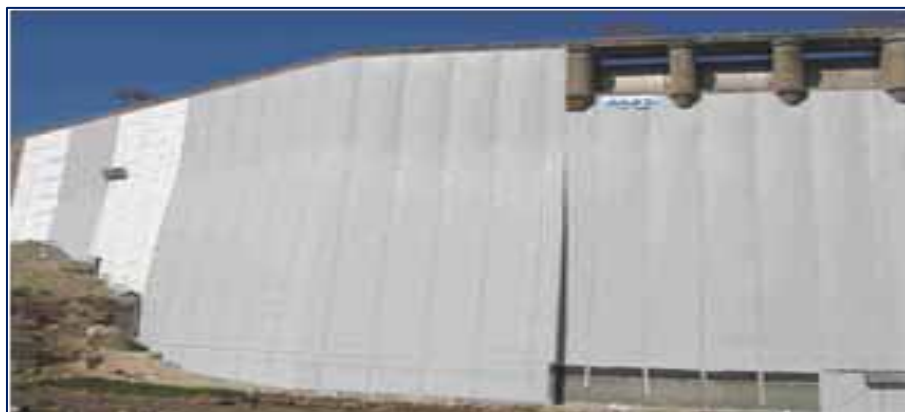
Figure: 3- The waterproofing PVC Geo-composite is installed over the Geotextile and fastened with the second component of the patented vertical anchorage system.

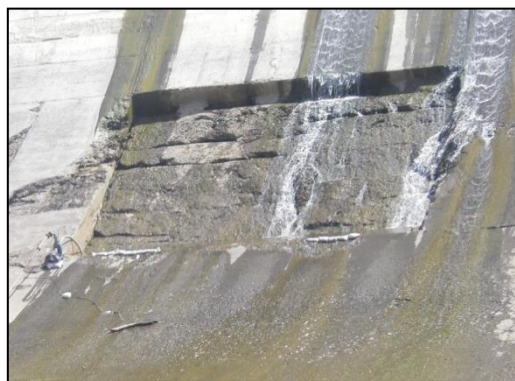
The type and extent of damages has been reduced over a period of time after achieving ogee shape in the year 2006 (December). Earlier in 1994 and onward when ogee shape was not reached damages observed were much more. The photographs of damages observed in different years are given below:

Damages observed in dewatering bay No. 5

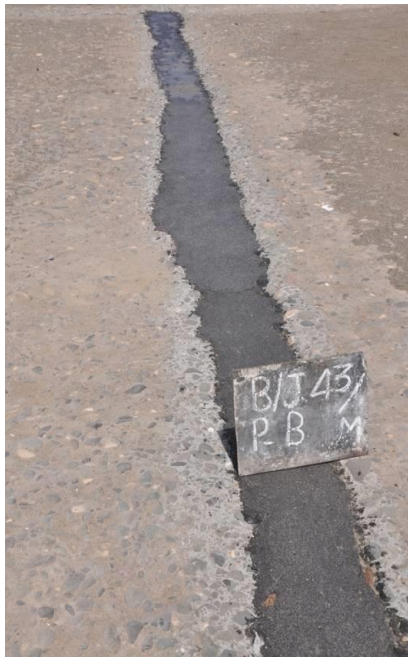
EPOXY TREATMENT IN JOINTS

- Apply a seal coat of Dobeckot - 505 C + Hardener EH-411 mixed in the ratio of 100:50 pbw.

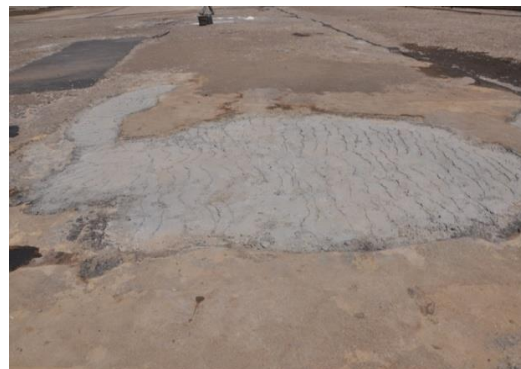
Bay-4 : BL. 44 – Panel-C – After Pouring Concrete

- Identify the area to be repaired and mark the same
- Removal of all loosed unsound material, algae or other foreign particles by wire brush, air & water jet at pressure 4 to 4.5 kg/cm<sup>2</sup>
- Make square edge of the patch / pot hole
- Make the patch in possible regular shape
- Apply a bond coat of Dobeckot – 505-C + Hardener EH-411 mixed in the ratio of 100:50 by weight
- Pour A20-S310-CL450 grade self-compacting concrete 25 mm below the design profile
- Cure the concrete for 15 days

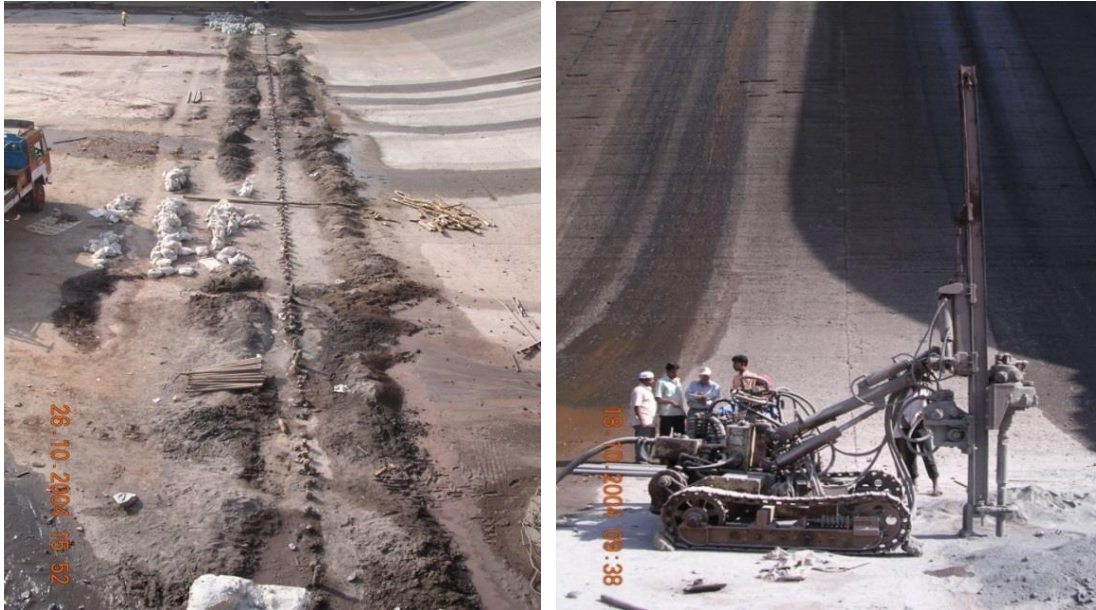
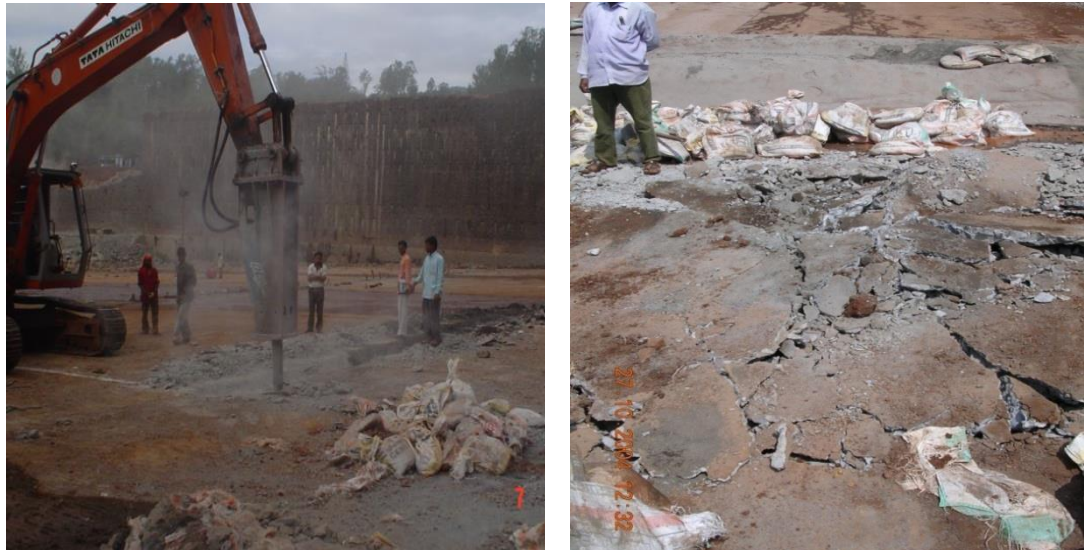
Figure 12: Breaking of reinforcement to enable concrete excavation and Face opening for concrete excavation is done

Line Drilling 115 mm dia 400 mm c/c upto full depth to provide separator between Dam & excavation plot

The foundation portion of the extended dam was previously the sloping apron of the stilling basin and as such it was covered with reinforced concrete. The thickness of the concrete varied from 70 cm to 270 cm. Initially it was planned to excavate the concrete and the rock in a similar manner. When drill holes were taken in the concrete and blasted, the holes used to get blown off. Sometimes the underlain rock used to get shattered

To overcome this problem, the concrete top was first broken using hydraulic breaker in the form of grid of 3m x 3m, to expose the reinforcement. The reinforcement bars were then cut using gas cutters. Regular drilling blasting as per the pre-determined pattern gave very good results later on.

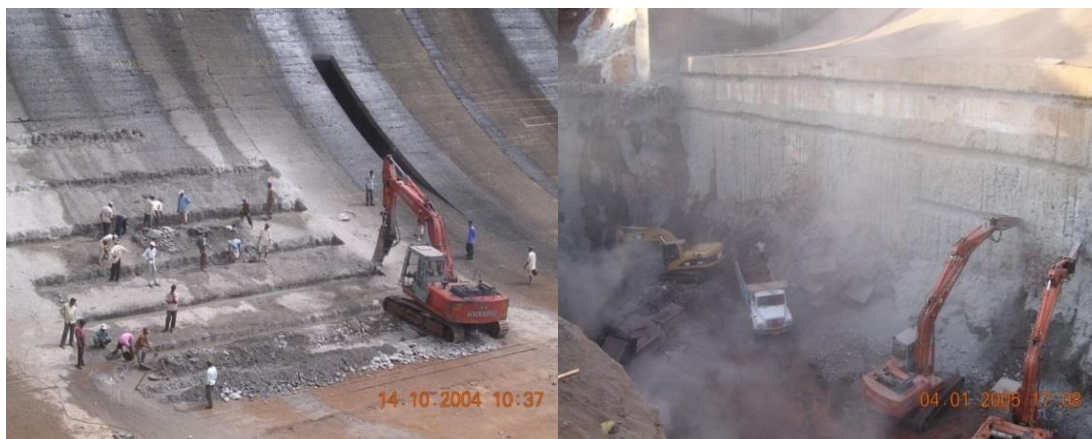
Figure 13: Cutting of Shear Keys

Shear keys were cut in the old concrete to have a proper bonding between the old concrete and the new strengthening concrete via closure concrete. Therefore, the success of the bonding depended upon the efficacy of the shear keys. However the cutting of shear keys was not only a difficult job but also a time consuming one. Efforts were made to cut these shear keys while the excavation was in progress to save the time during concreting period. However, the cutting went on lagging behind and subsequently it was abandoned at certain locations as the excavation which was equally critical and time bound could not be stopped. Once the concreting started, the hydraulic breaker could not be employed for cutting the shear keys. And also, as the concreting progressed as per the time schedule, it was difficult to work with the usual tools in the limited space of 1.2 m between the two concretes. One innovative method of using drilling and splitting concrete solved this problem. The concrete face where shear keys are to be cut was drilled using 50 mm dia drill for a depth equal to the size of the shear key. Hydraulic splitter was used to wedge out the concrete in this portion. This method proved to be effective and fast and all the balance shear keys were cut in time and to their full section.

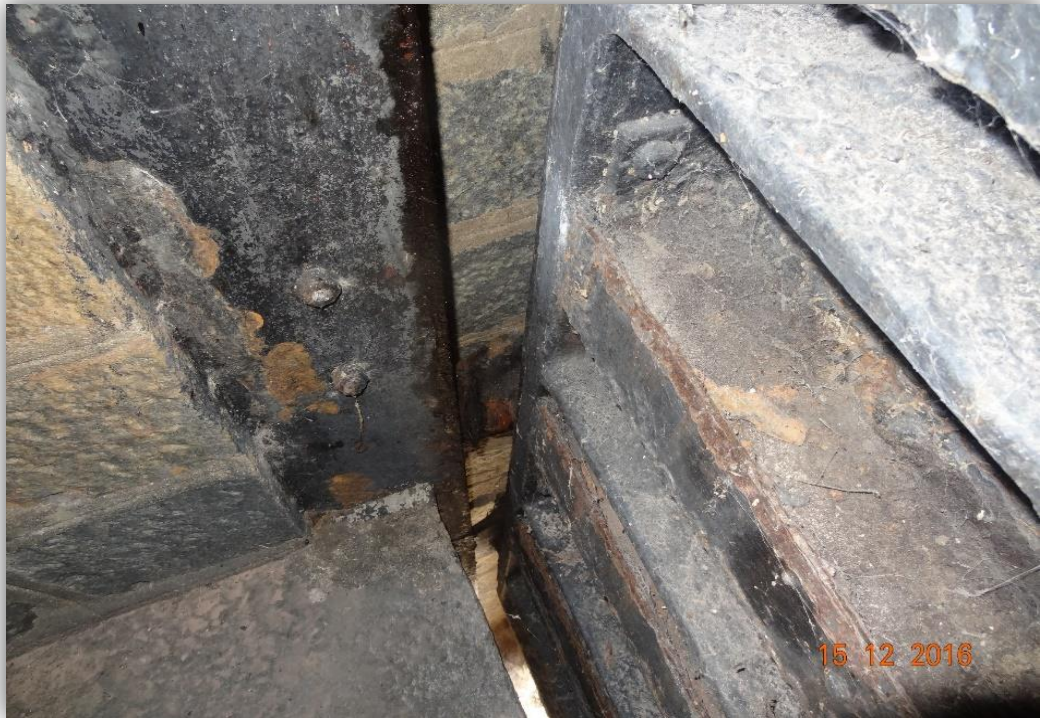
+103' gate and embedded parts - looking from d/s side.

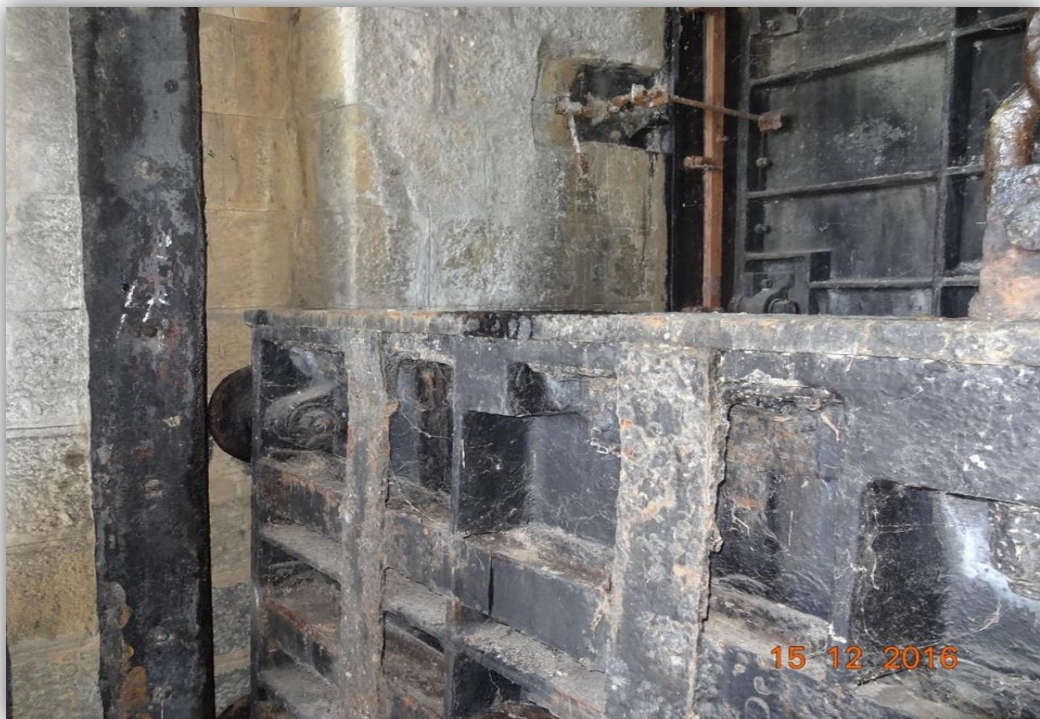
+103' sluice gates in partial open condition with +114' gate in the background - looking from d/s side.

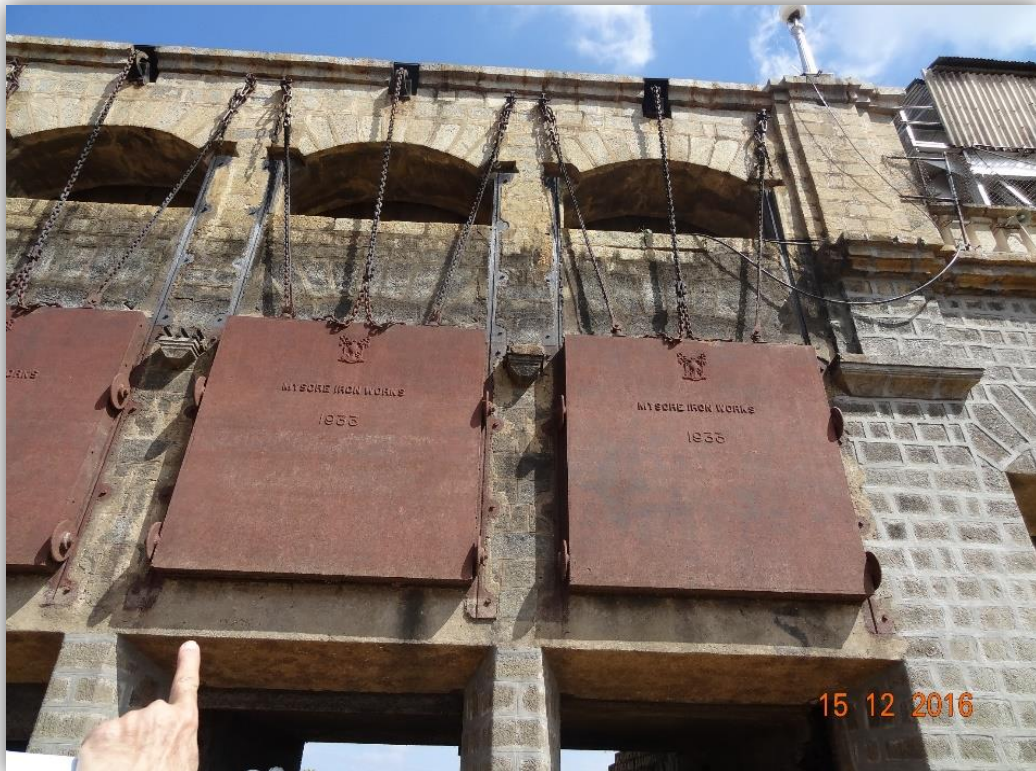
Existing +114' gates in hanging position over +103' sluices.
