**GOVERNMENT OF MAHARASHTRA
WATER RESOURCES DEPARTMENT**

**Annual Consolidated Health Status Report of
Canals and Canal Structures
(2017-18, 2018-19 & 2019-20)
(Based on Test Inspections by DSO, Nashik)**

**Superintending Engineer,
Dam Safety Organisation,
Nashik**

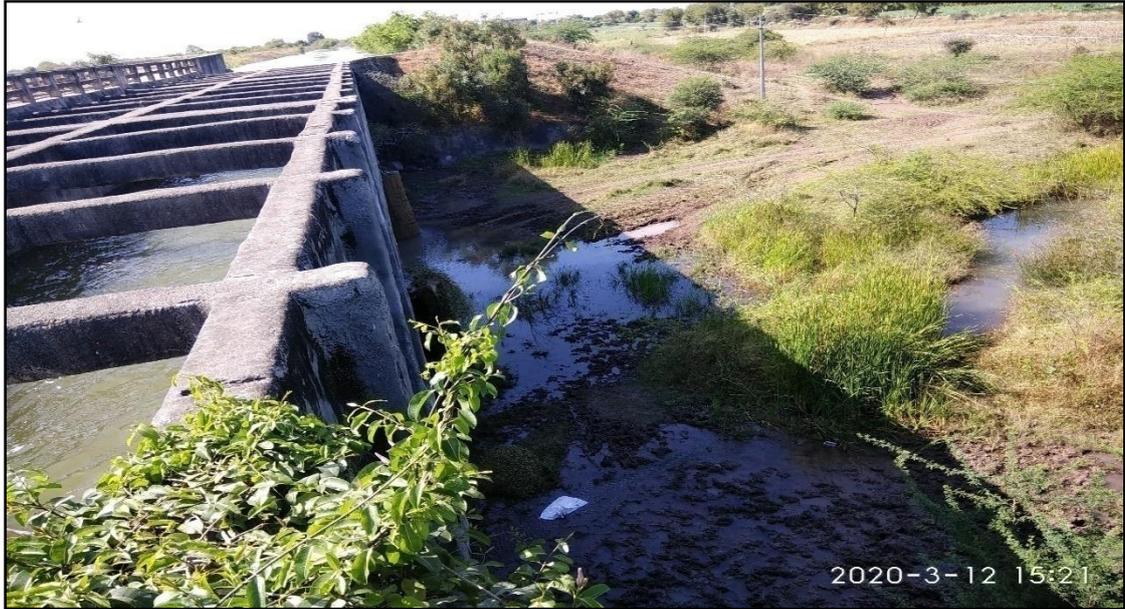
Name of Structure: Bhaigavan Aqueduct at Ch. 66.559 km.

Deficiency: 1) Heavy leakage was observed through joint between vertical and bottom left and right side of trough near pier.
