# Manual for Rehabilitation of Large Dams

Doc. No. CDSO\_MAN\_DS\_02\_v1.0

**January 2018**

**Central Water Commission  
Ministry of Water Resources,  
River Development & Ganga Rejuvenation  
Government of India**

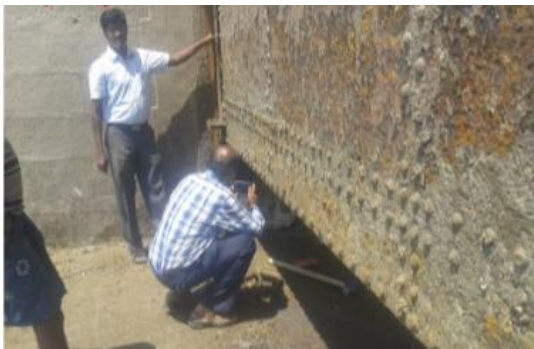
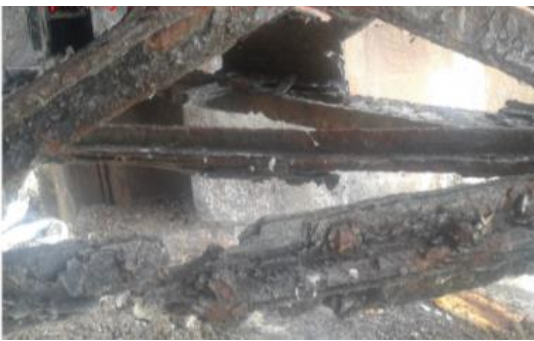
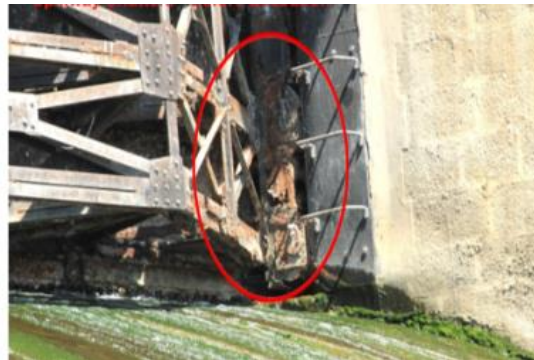
Figure 7-8: Before Rehabilitation

(Krishnagiri dam- spillway vertical lift gates)

The aged worn out spillway gate installations are being strengthened in localized areas by replacement of worn out sections or strengthening of the horizontal girders and the vertical stiffeners etc. (Figure 7-10).

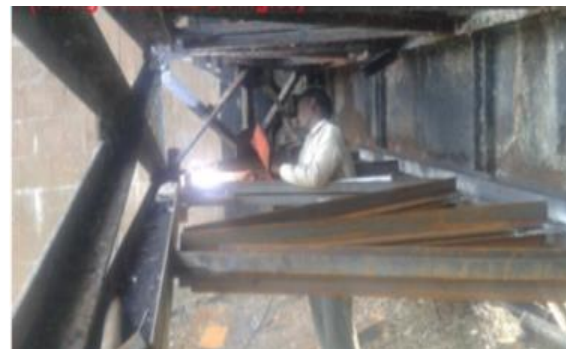
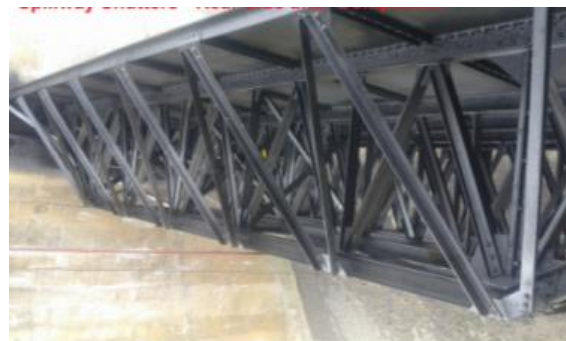
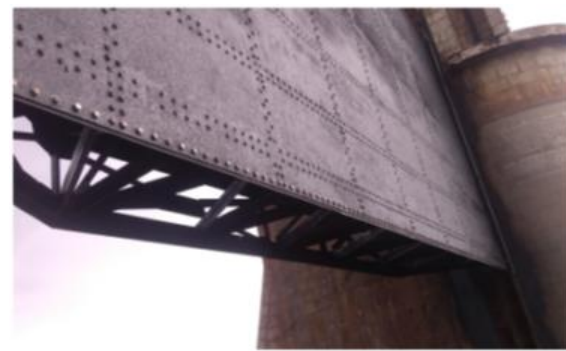
Figure 7-9: After Rehabilitation

(Krishnagiri dam- spillway vertical lift gates)

- Strengthening of the gate horizontal Girders / vertical stiffeners.
- Sand blasting / Copper slag blasting
- Zinc metallizing (200 micron)
- Application of Zinc Primer (40 Micron)
- Application of Epoxy Coal-tar Paint (2 coats of 100 micron each)

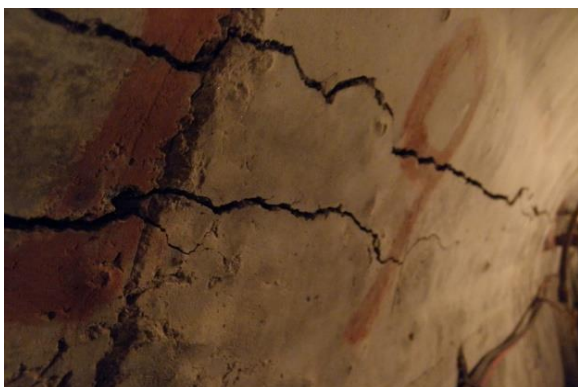
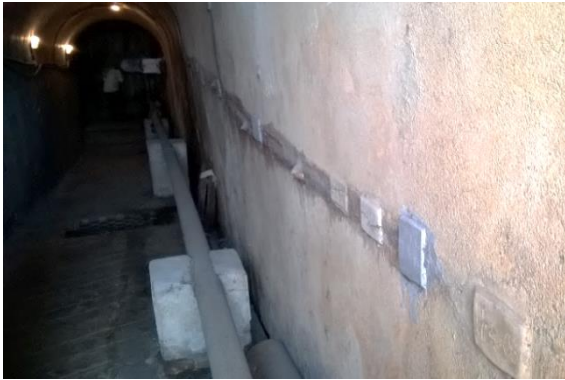
Photograph 5 - Cracks in Access/Operating gallery

- The cracks may be repaired with low pressure normal grouting with cementitious materials – restricting the use of admixtures to shrinkage reduction only and not by epoxy based materials. Grouting of cracks shall be done at a time when the cracks are in fully open position i.e. during the months of summer.

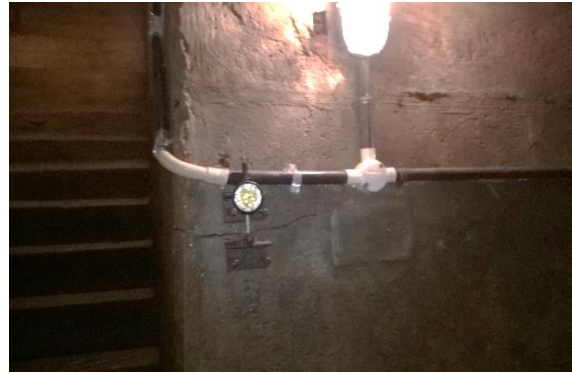
Photograph 6 - Cracks in Foundation/Drainage gallery

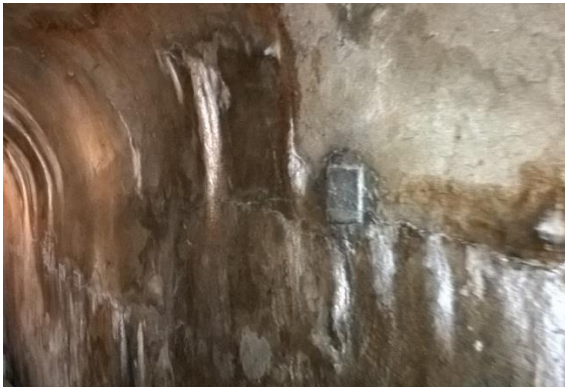
The photographs 7 and 8 show the Cracks in downstream face and upstream face of Non-overflow section respectively.

Photograph 7 - Cracks in downstream of Non-overflow section

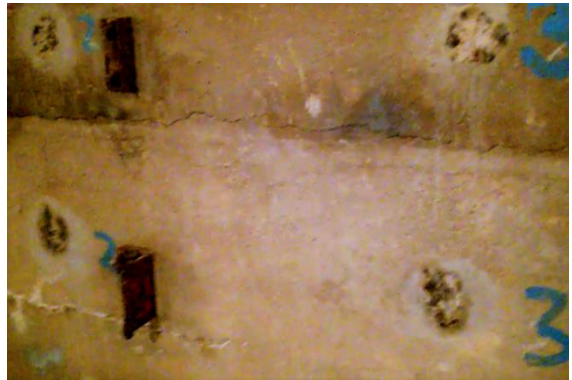
Photograph 8 - Cracks in Upstream of Non-overflow section

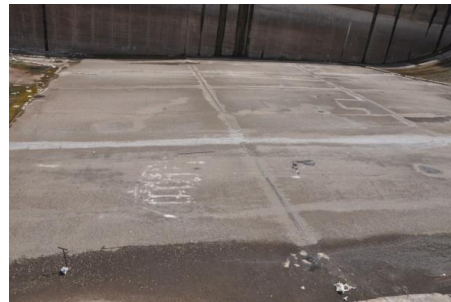
REPAIRS OF JOINTS

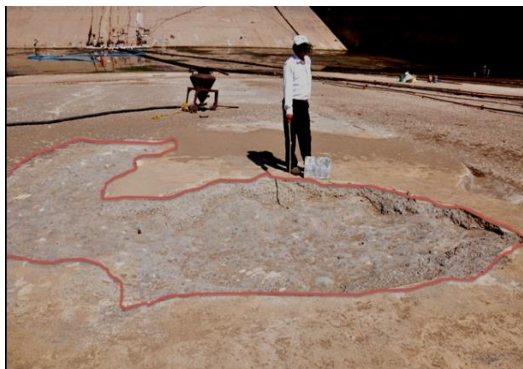
Bay: BL 44 – Panel C – Patch before Treatment

- Identify the area to be repaired and mark the same
- Removal of all loosed unsound material, algae or other foreign particles by wire brush, air & water jet at pressure 4 to 4.5 kg/cm<sup>2</sup>
- Make square edge of the patch / pot hole
- Make the patch in possible regular shape
- Apply a bond coat of Dobeckot – 505-C + Hardener EH-411 mixed in the ratio of 100:50 by weight
- Pour A20-S310-CL450 grade self-compacting concrete 25 mm below the design profile
- Cure the concrete for 15 days

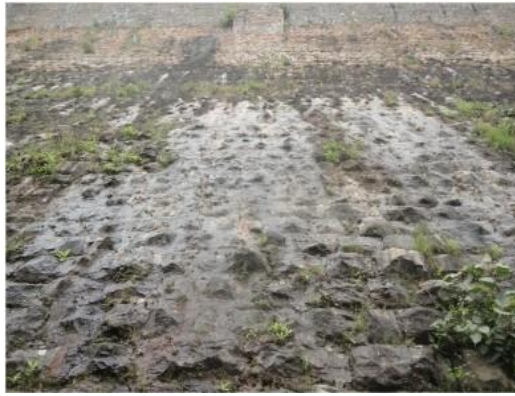
Photograph- 2

- Sweating on downstream face masonry portions between Ch 1460 to 1850 (photo-3).
- Leaching of pointing mortar at some places
- Springs of water on downstream face at CH 2120 (Photograph -2 & 3)

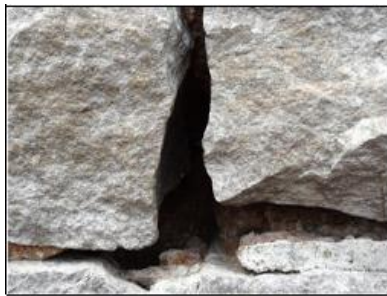
Photograph- 4

- Damages in seals of the gates leading to leaking through these seals particularly in gate nos. 1,9,10,12,14,15,19,23,25,28 to 36 of +106' & +103' level sluice gates.
- Peeling off the mortar in masonry joints of apron with pitting on surface
- Distresses on upstream face like deep and wide openings between adjacent masonry rocks and loosened masonry stones.(Photo- 4,5,6)

1. Cleaning of the masonry joints with high water pressure jet to remove loose materials inside
2. Application of a coat of algae fungi removal
3. Drying the cavities by air pressure

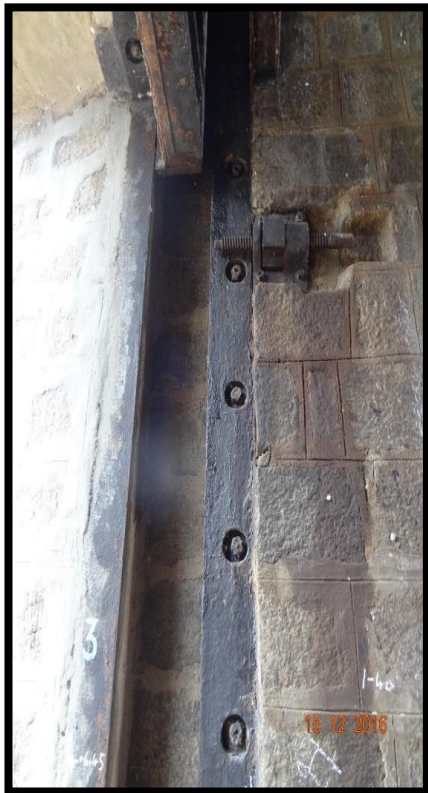
Existing gates groove and embedded parts for +106' gates
